**UNITED STATES DEPARTMENT OF TRANSPORTATION
NATIONAL HIGHWAY TRAFFIC SAFETY ADMINISTRATION**
1200 New Jersey Avenue SE
Washington, D.C. 20590

EA15-001
Air Bag Inflator Rupture

**REPORT OF TK HOLDINGS INC. PURSUANT TO PARAGRAPH 33.a
OF THE NOVEMBER 3, 2015 CONSENT ORDER**

June 30, 2016

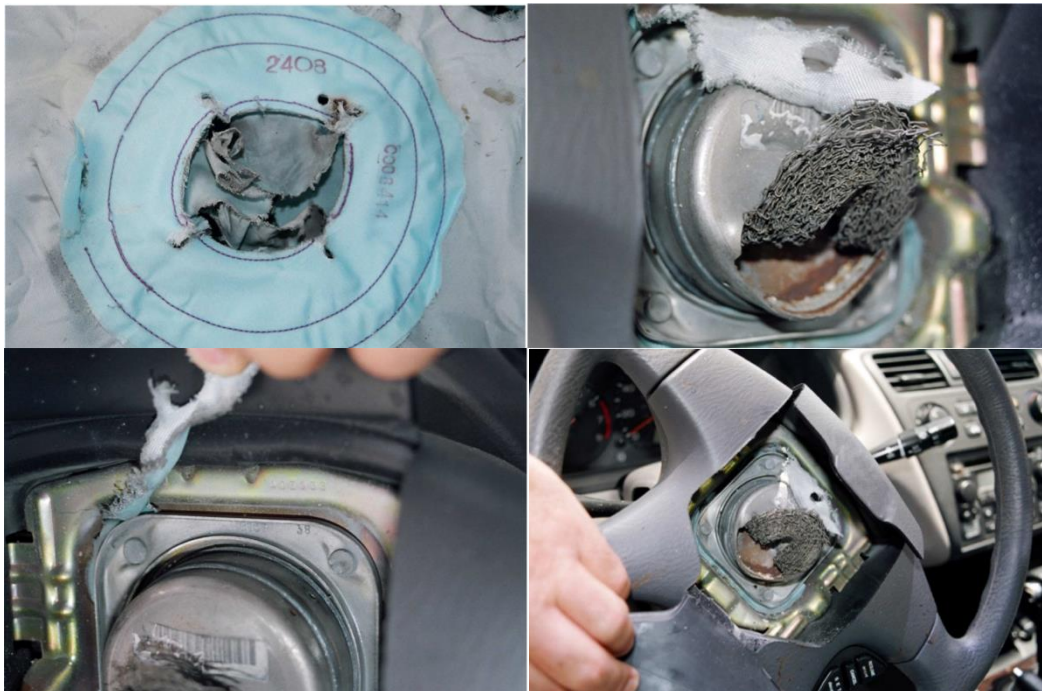
Pictures of Event 0 Received May 6, 2005

On Monday, June 13, 2005, a U.S. engineer in the inflator production group summarized his opinion of Event 0 based on very limited data. The engineer concluded that:

- the anomaly probably initiated in the secondary chamber in the cap material in the region of the booster tubes;
- the anomaly appeared to be due to high pressure, not low material strength;
- rust in the interior is localized and deep which may have indicated that it existed prior to the deployment due to a high interior moisture; and
- rust appeared next to the crack surface, but not on the crack surface, supporting the theory that the interior rust likely existed prior to the event.

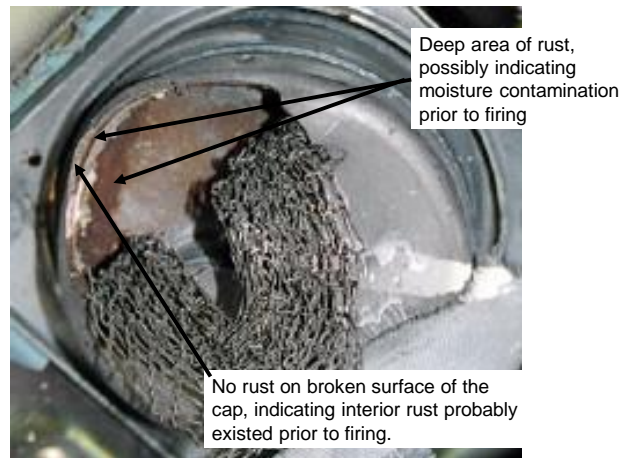
Picture from a U.S. Engineer's June 13, 2005 Analysis

Assuming the rust existed prior to deployment, the engineer concluded that the event could be explained by interior moisture that could cause the suspected over-pressurization by degrading the propellant's physical properties, resulting in excessive wafer break-up, high surface area, and subsequent high pressures. Under this hypothesis, the engineer explained that the interior moisture was either: (i) manufactured into the product (wet filter, wet propellant, etc.) or (ii) leaked into the inflator through a compromised seal. In addition to the possibility of moisture intrusion, the engineer identified other factors that also may have caused the observed over-pressurization: (i) excess main propellant (*i.e.*, too many batwings) or (ii) excess booster propellant in the igniter assembly.¹⁷ The engineer noted that no further effort could be conducted because the subject inflator had not been returned for analysis.

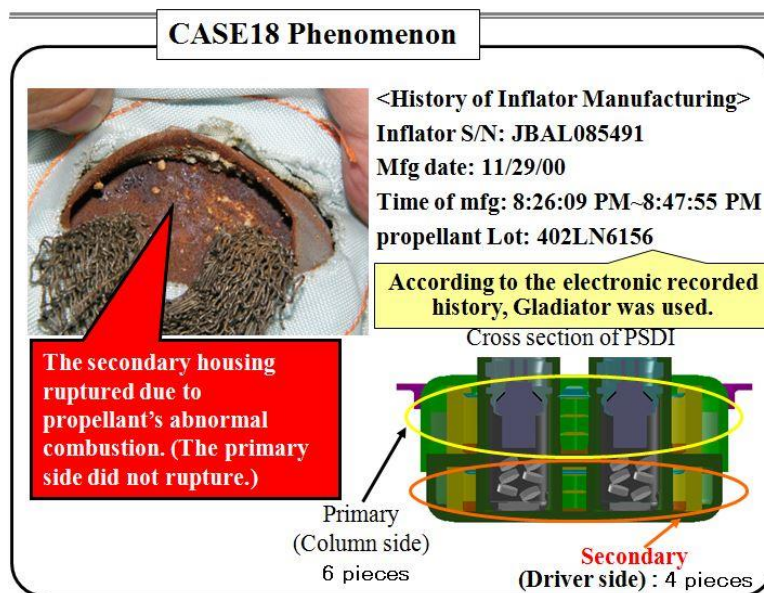
On August 1, 2011, a PSDI inflator ruptured in a vehicle in Pompano Beach, Florida (“Case 18”). Takata’s records indicated that the Case 18 inflator was manufactured using propellant from the Gladiator 1 press. Notably, only the secondary chamber of the inflator ruptured (see explanation and images, below).

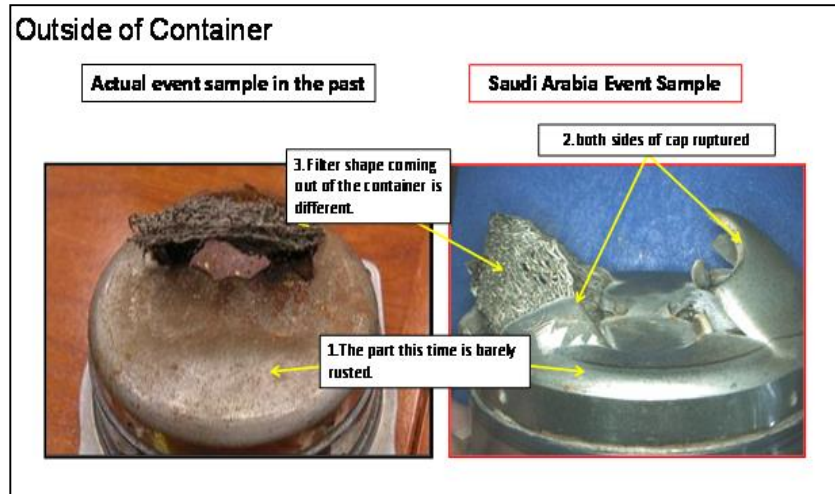
In a meeting with the vehicle manufacturer in April 2012, Takata presented the results of its initial analysis of the Saudi Arabia event sample and its manufacturing inspection records. Takata underscored that there were several differences between the appearance of the Saudi Arabia event and a sample from a past PSDI event, including a lack of rust, a rupture of both sides of the inflator cap, and a difference in the appearance of the exposed filter (pictured below).

Through inspection of the Saudi Arabia event inflator, Takata found no deficiencies in assembly, no deformation on the booster cap, and no ruptures on crimps or welding. Takata thus ruled out as root causes (i) an insufficiently strong inflator housing, (ii) an overly aggressive ignition, and (iii) an insufficient gas outlet area. Through manufacturing records for the event inflator, Takata also confirmed that the press compaction load, density, moisture level, and propellant chemistry met specification.

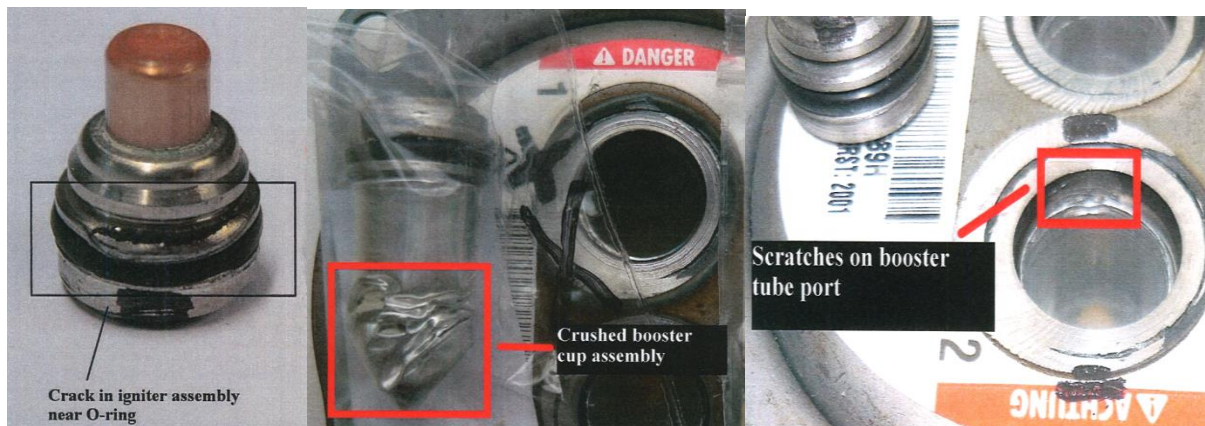
In total, 18 of 60 PSDI inflators (30 percent) examined by Fraunhofer had suffered some physical damage (categories 1-4, above) during manufacturing, and 6 of 60 (10 percent) had severe damage.

Fraunhofer hypothesized that welding heat, along with other potential manufacturing processes, caused the imprecise fitting of the component parts and resulting damage. The cracks in the igniter assemblies, as well as the other abrasions and dents, could promote moisture intrusion, which could worsen over time. In addition, the crushed booster cup assembly caused broken 3110 tablets, which could make the booster propellant more energetic and could adversely affect ballistics during ignition. Because these inflators had been dissected, no ballistic tests could be performed to determine the possible effects upon the performance of these inflators.

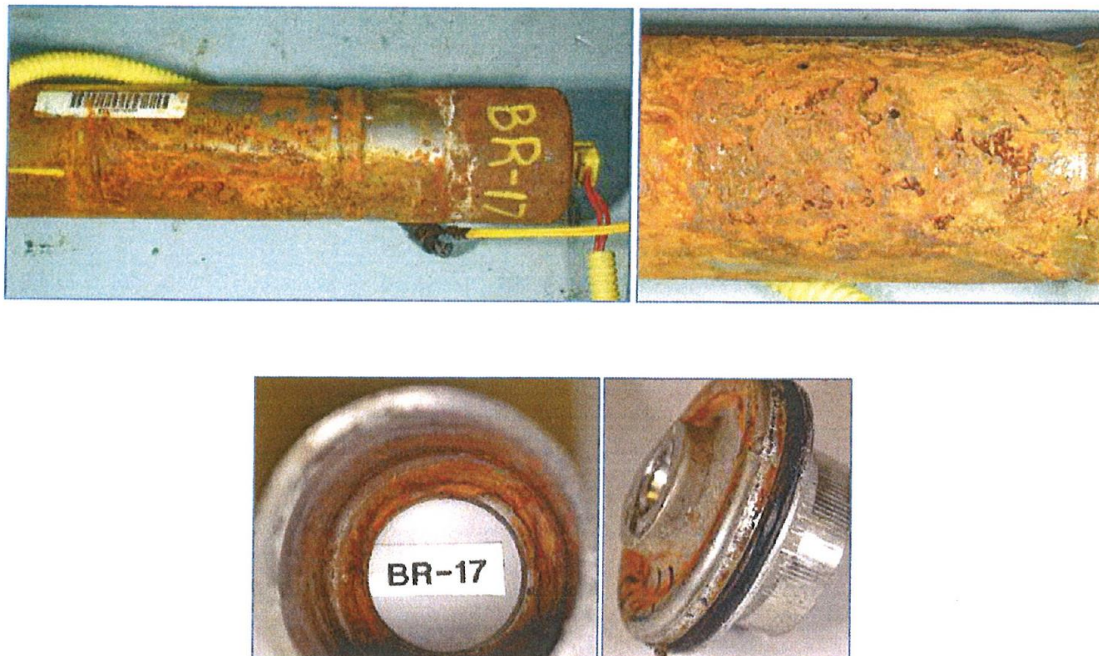
Figure 4. PSPI-L Disassembly showing Moisture Intrusion through the End Crimp

The dissection of 19 PSPI inflators from high temperature and high humidity areas of Puerto Rico, Florida, Texas and Alabama, however, resulted in (i) evidence of moisture intrusion into the inflators (as well as external rust, severe on about 25 percent of the inflators) (see photos, below), and (ii) a scientific explanation for the possible ability of moisture to permeate through rubber and plastic materials in certain warm and humid climates (see section XIII.G).

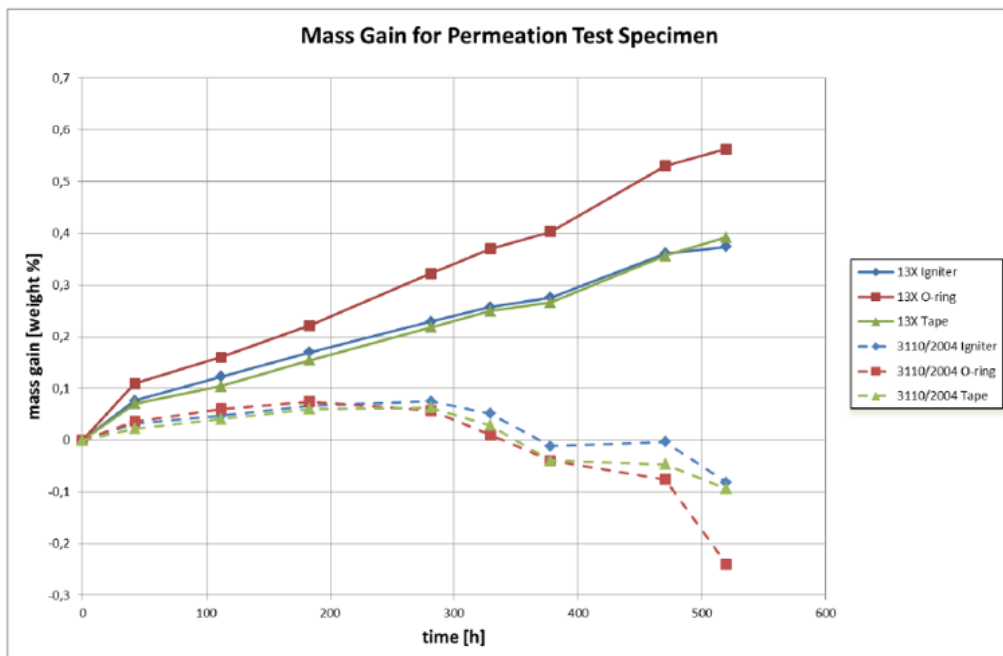
Moisture permeation through O-ring, igniter, and tape seal, with and without 13X.

On the second issue—the location and rate by which moisture is permeating into and out of inflators—Fraunhofer found that water was transferring more rapidly through the O-ring, followed by the igniter and tape seal, which showed a similar rate. Furthermore, moisture was entering the inflator faster when 13X desiccant was in the inflator, due to the desiccant’s absorption of moisture causing a higher concentration gradient, though there is no indication the desiccant’s neutralizing effect was compromised. Both relationships can be seen in the graph below.⁵⁷

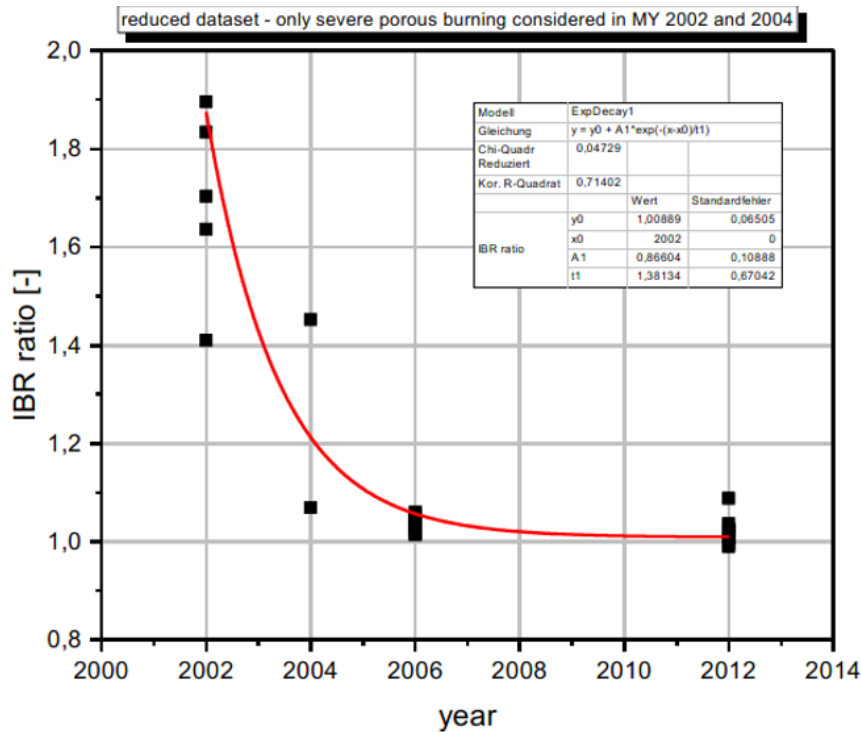
Burn rate increase over baseline increases exponentially for inflators older than 2006.

On the fourth issue—the creation of a service life prediction model for Takata inflators—Fraunhofer conducted ballistic testing on 20 field returned inflators from south Florida with different manufacturing dates (all from the same inflator type and “worst case” vehicle model). Fraunhofer then compared the burn rates of these field inflators to the burn rate of virgin 2004 propellant. Fraunhofer found that there was no porous burning in wafers from 2006 or younger. For inflators older than 2006, Fraunhofer found that the burn rate was increasing with age. This result can be seen in the graph below, which plots the relative increase in burn rate by inflator year, with the burn rate of newly made propellant expressed as 1.0.

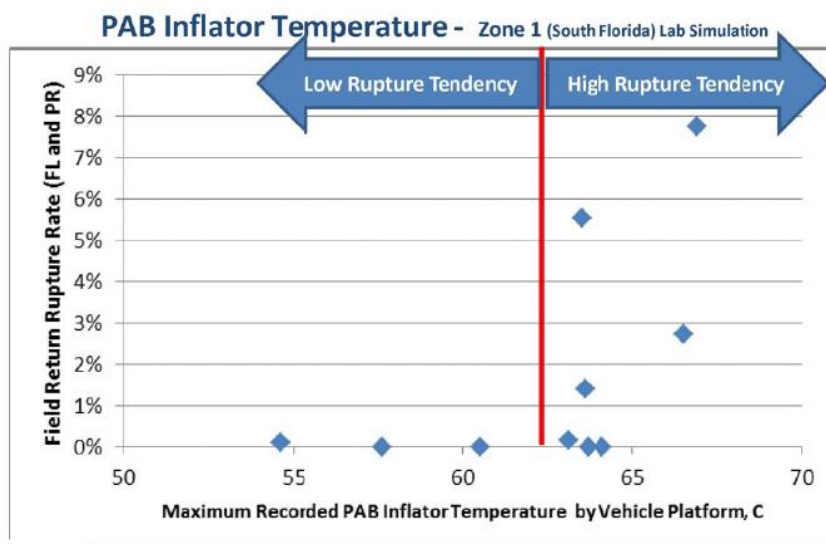
Vehicles that exhibit higher inflator temperatures generally have a higher observed rupture rate

As can be seen, only in certain vehicle types does the interior temperature regularly rise above 60°C. This fact appears to be significant, Takata observed, because rupture rates appear to increase as the maximum passenger airbag temperature rises above 60°C, as show below:

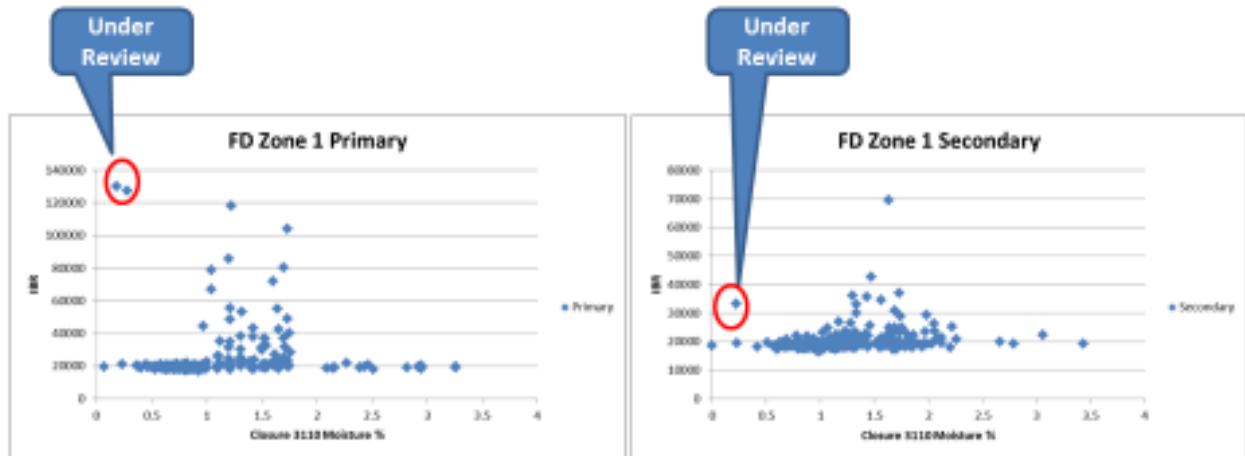
- There appears to be good support for the existence of a moisture threshold needed to convert the propellant.
- We typically do not observe HIGH burning rates with LOW moisture, but there are three test cases that are currently under examination.

With the exception of the three tests circled in red, increases in burn rate are not seen until moisture levels reach approximately one percent. Takata also again confirmed that its testing is showing that moisture alone, without aging, does not alter burn rates. Takata reiterated that moisture is necessary but not sufficient; high temperatures are also required.

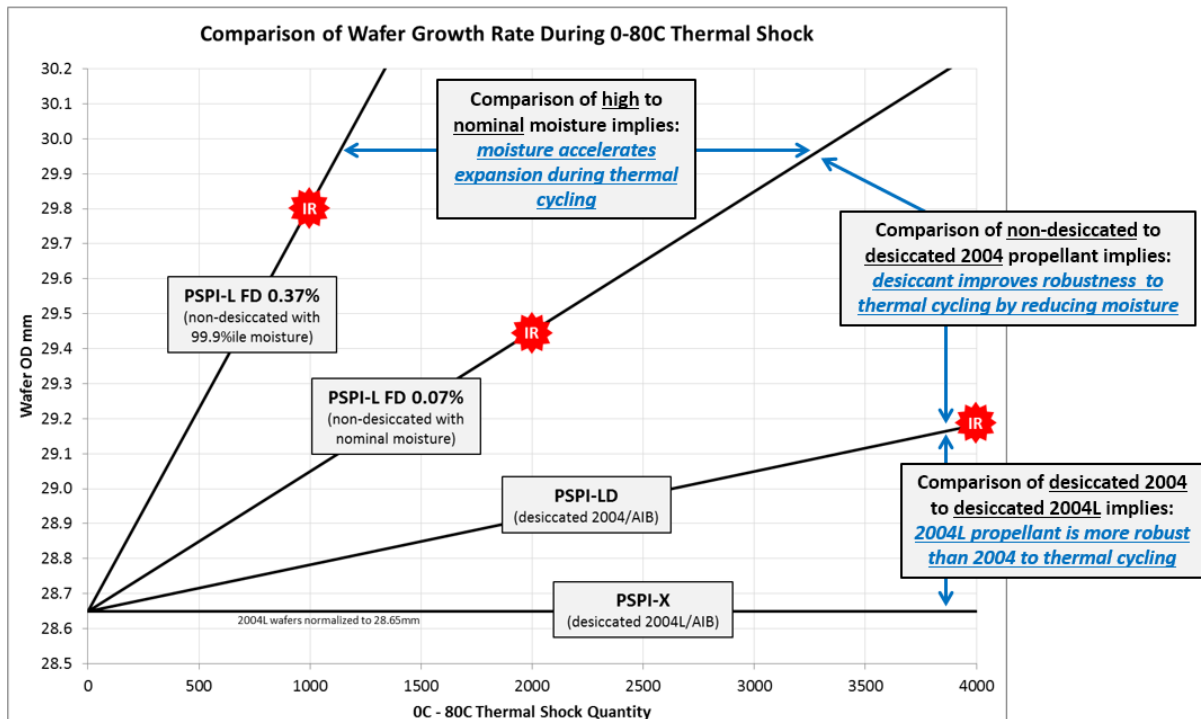
The relative robustness of cylindrical passenger inflators studied here can be compared by looking at the wafer growth rate:

The use of the 2004L propellant and the addition of desiccant appear to prevent grain growth (represented by the slope of the line), such that no grain growth was observed in the desiccated 2004L propellant after 4000 cycles.
