FIELD STUDY INVESTIGATING THE POTENTIAL OF WATER QUALITY TESTING TO
PREDICT CORROSION IN BOREHOLES IN NORTHERN UGANDA

A Thesis Submitted to the Graduate Faculty
of Mercer University School of Engineering
in Partial Fulfillment of the
Requirements for the Degree

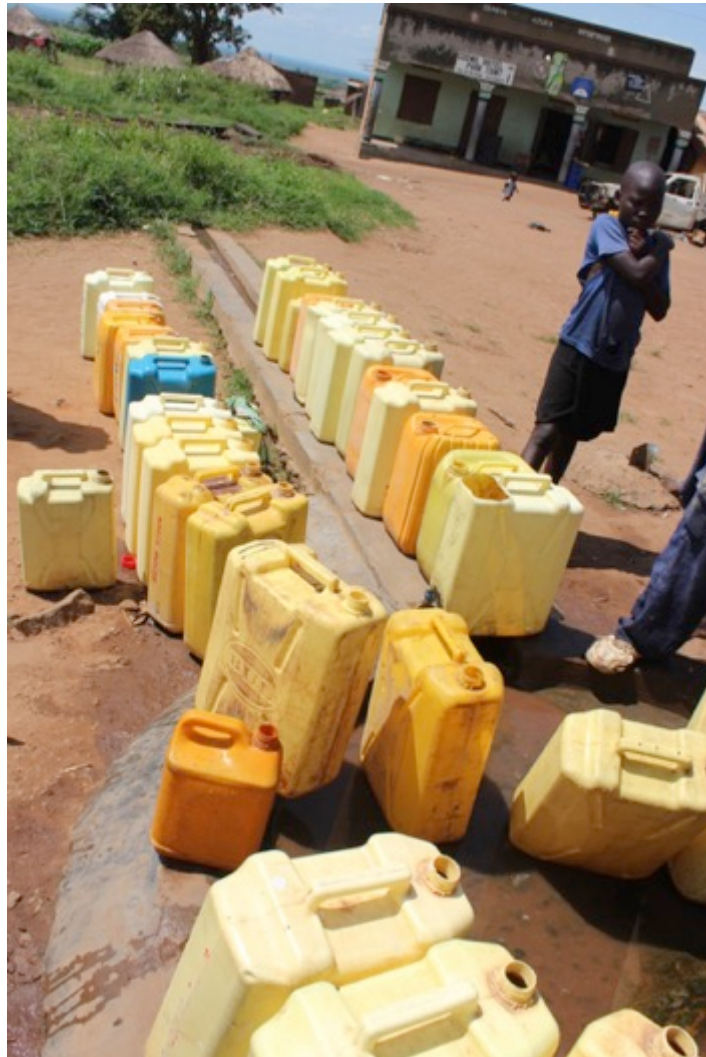
Figure 3. After the women or children reach the borehole, they could have to wait hours to fill their jerry cans. (borehole 4) Photo courtesy of Jake Carpenter.

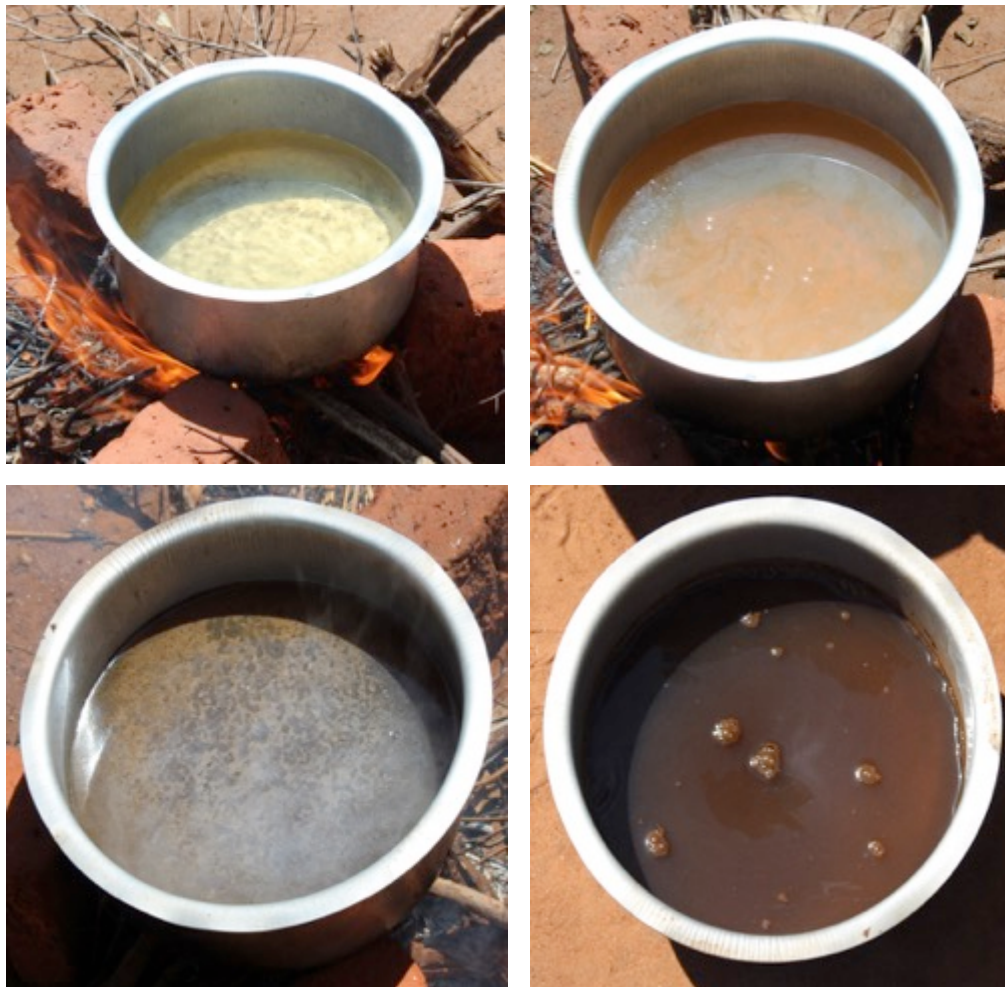
Figure 4. Water color of a sample of water taken from a Northern Uganda borehole progressively darkened as it was heated to a boil (left to right). The image in the fourth quadrant shows the state of the water once removed from the fire. The borehole has been chained up because the community did not deem the water acceptable for use. Many prefer collecting water from the unprotected spring. (Photos courtesy of Jake Carpenter)

the water becomes a health concern [6]. Water may give off an odor or may turn a different color due to high concentrations of different contaminants. This can lead to the abandonment of a water source and can result in families having to travel further to collect their daily water (*Figure 4*).

Families cannot be expected to use the water from boreholes like that shown above for any tasks that require boiling water. The boiled water would certainly stain food, clothing, etc. (*Figure 5*).

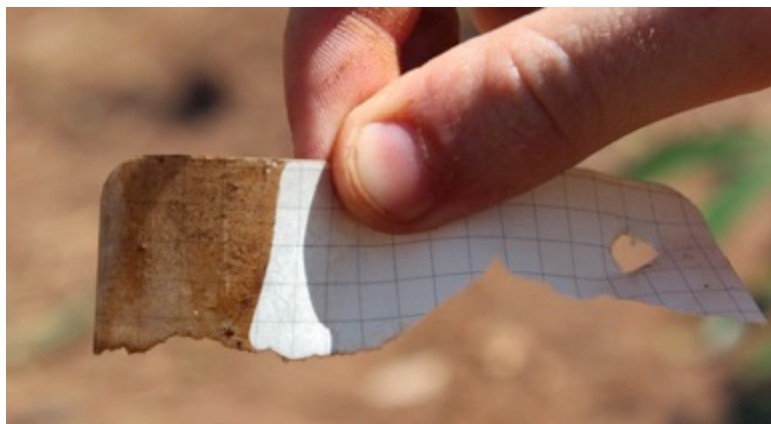
Figure 5. A piece of paper dipped in the water from the fourth quadrant pictured above in *Figure 4*. Photo courtesy of Jake Carpenter.

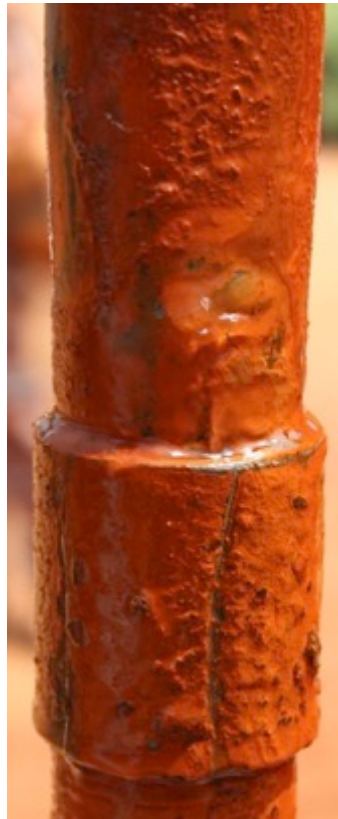
Figure 6. Results of corrosion from rehabilitated borehole in Northern Uganda. Photo courtesy of Jake Carpenter.

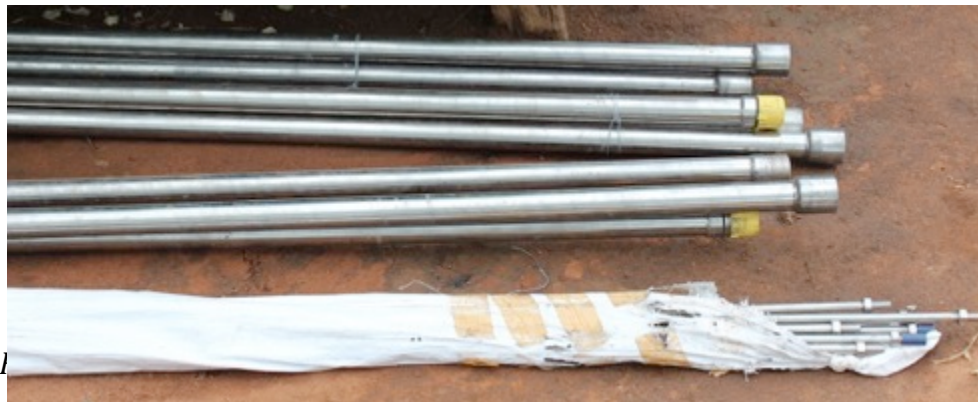
Figure 7. Stainless steel rising mains and rods used to rehabilitate two boreholes in Northern Uganda. Photo courtesy of Jake Carpenter.

Langenegger states that, “As a general rule...stainless steel rising mains and rods are about 3-5 times more expensive than galvanized ones” [18]. In terms of capital cost, stainless steel (SS) is the most expensive corrosion resistant option for handpumps, but SS may be the best option financially when considering maintenance costs long-term. “Steel pumps have the additional advantage that they are less vulnerable to the sort of shock loads sometimes imposed during loading and unloading in developing countries.” However, SS is heavier, which can be an issue when replacing pipes [31]. *Figure 7* shows SS handpump components.

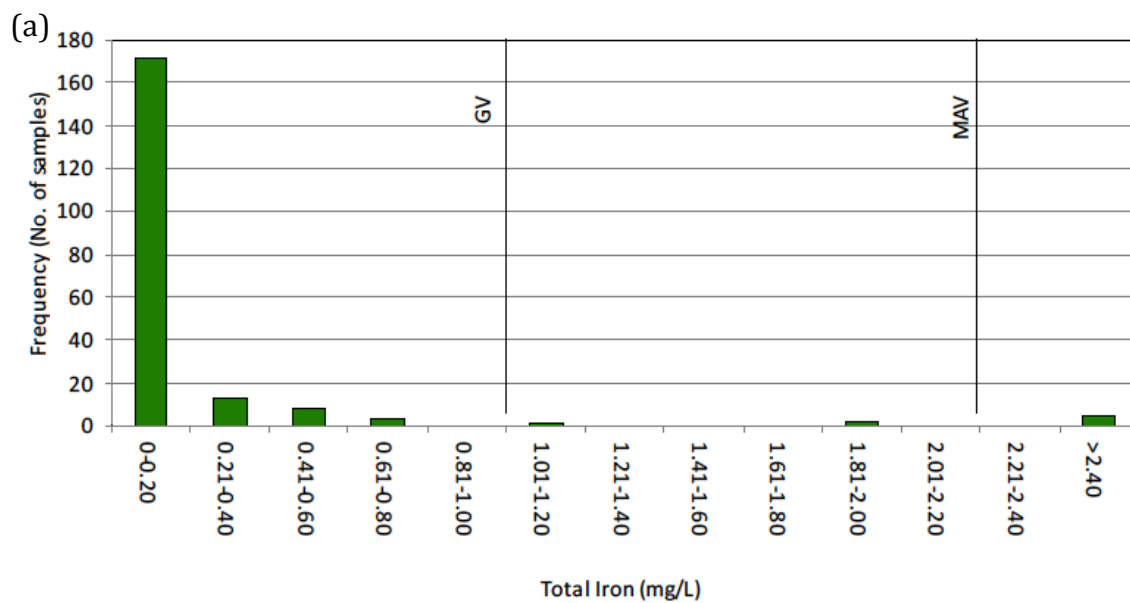
Figure 9. Total Iron concentration data for the Oyam District (a) statistically distributed (b) spatially distributed

The GV for iron is set at 1 mg/L and the MAV at 2 mg/L. The Directorate of Water Resources Management (DWRM) reported that, “Ninety six percent of the concentrations recorded are below 0.8 mg/L. Three boreholes have concentrations between the GV and MAV and 5 boreholes recorded concentrations greater than the MAV” [37]. The distribution of this iron concentration data is displayed statistically and spatially in *Figure 9*. Further details concerning groundwater quality data can be found in the Oyam District Report.

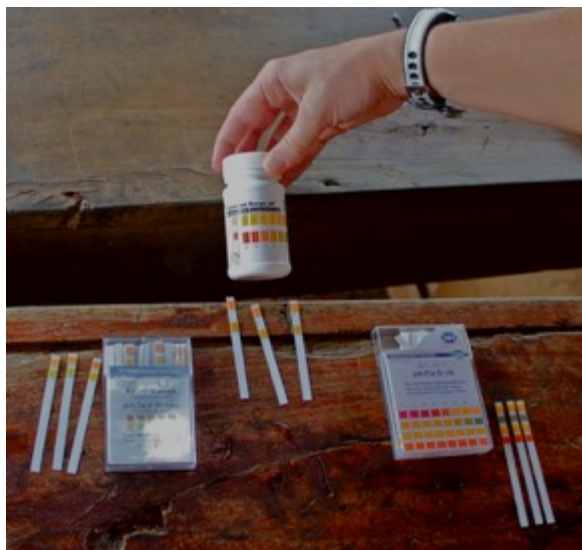
Figure 14. From left to right: Youth Waters, Extended Range, MN pH test strips in triplicate (Photo courtesy of Jake Carpenter)

At each borehole site, four 100-mL water samples were taken within the same pump stroke. Three of the water samples collected were dedicated to a different pH strip type, and pH measurements were conducted in triplicate with each type of pH strip (*Figure 14*). The fourth beaker of water was used to measure conductivity, pH, and TDS with the Hanna probe. A three-point calibration curve was performed daily for the portable probe using commercial buffers of pH = 4, 7, and 10.

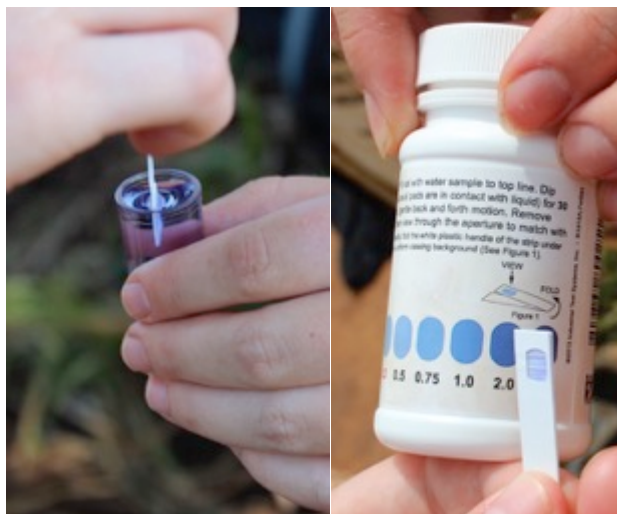
Figure 15. L: 30 seconds of gentle stirring followed by a 2-minute wait time with the strip removed from the sample. R: Matching strip to closest color on the container. (Photos courtesy of Jake Carpenter)

manufacturer (*Figure 15*). The SenSafe™ strips allowed iron concentrations to be quantified from 0.1-5.0 ppm (mg/L) with a detection sensitivity of 0.1 ppm (mg/L).

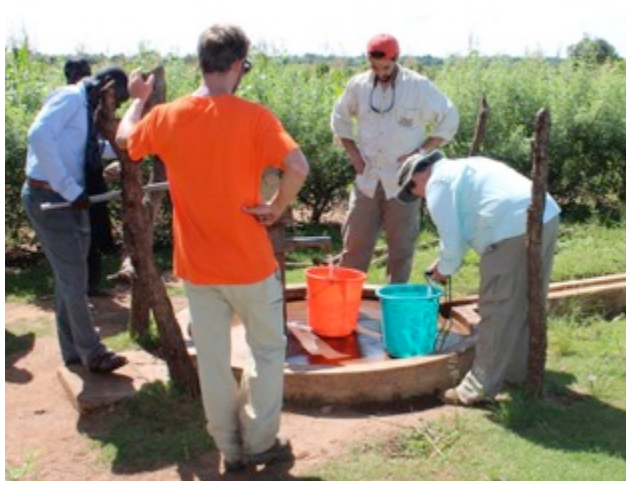
Figure 16. Measuring pH, conductivity, and TDS with the Hanna probe during a pump test at borehole 16.

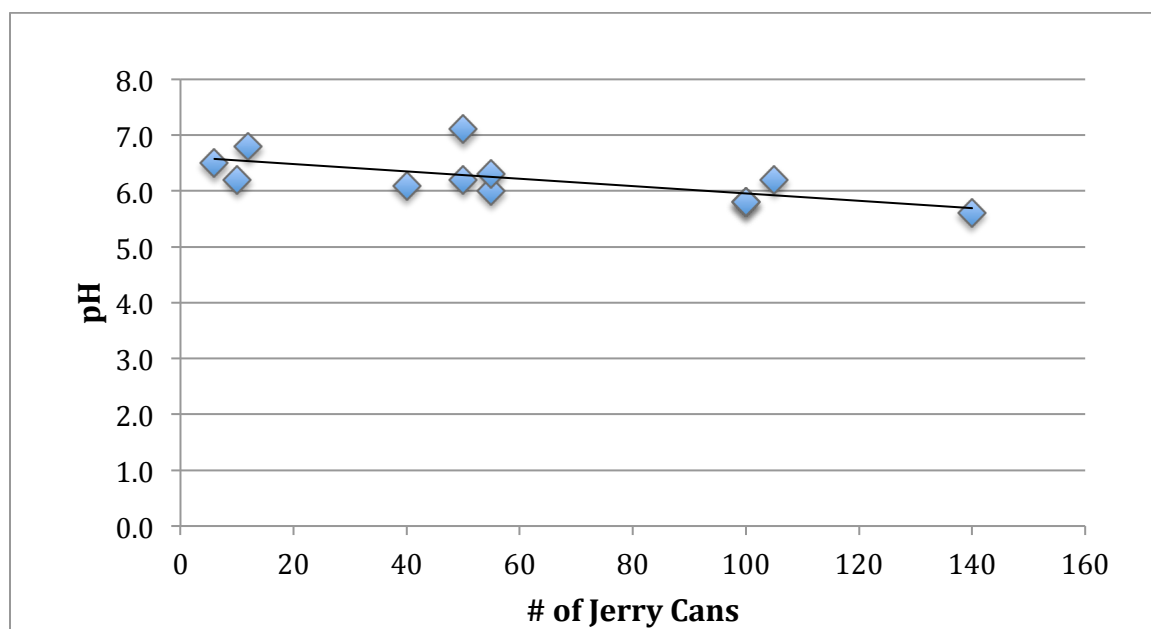
Figure 20. There is a negative linear relationship between the pH and the number of jerry cans pumped.

where J = number of jerry cans. See *Figure 20*. These data suggest that with continued pumping of the borehole, pH decreases.

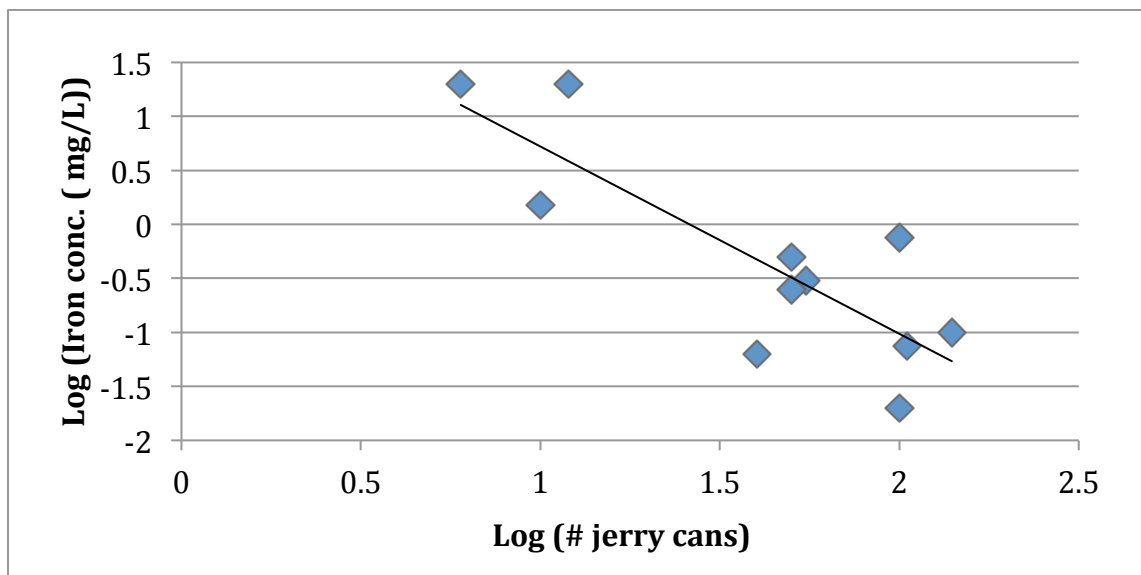
Figure 23. A relationship between the logarithmic of iron concentration and the number of jerry cans pumped can be deduced.

where J = number of jerry cans. See Figure 23. As the number of jerry cans pumped increases, the iron concentration decreases. This relationship suggests that the iron levels in the boreholes tested were at least partially due to corrosion. Langenegger et al. observed similar trends in their research of iron concentration in boreholes in Ghana [18], [19], [27]. They observed that as more water was pumped, the iron levels dropped and stabilized.

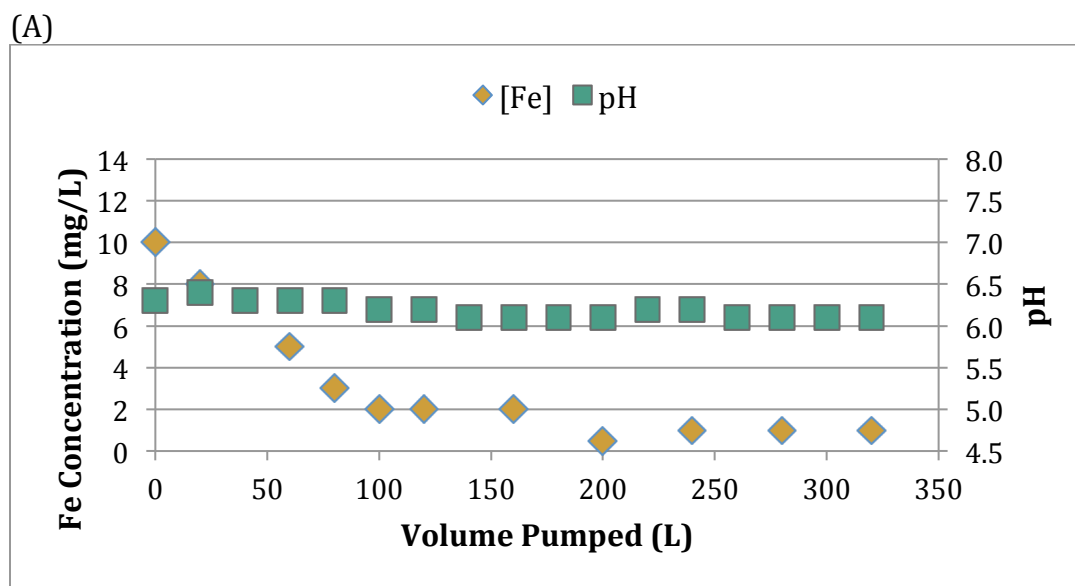
Figure 25. Borehole 14 pump test results (A) pH stabilizes around 6.15 and iron concentration stabilizes at 1.0 mg/L. (B) Conductivity and TDS stabilize at 0.15 mS/cm and approximately 114 ppm, respectively.

the pH of the water as it sits overnight. Once dissolved oxygen is reintroduced to the bulk water by pumping, ferrous iron is converted to ferric iron causing the initial red color of the effluent. The pH drop observed in Pump Tests 1 and 2 of borehole

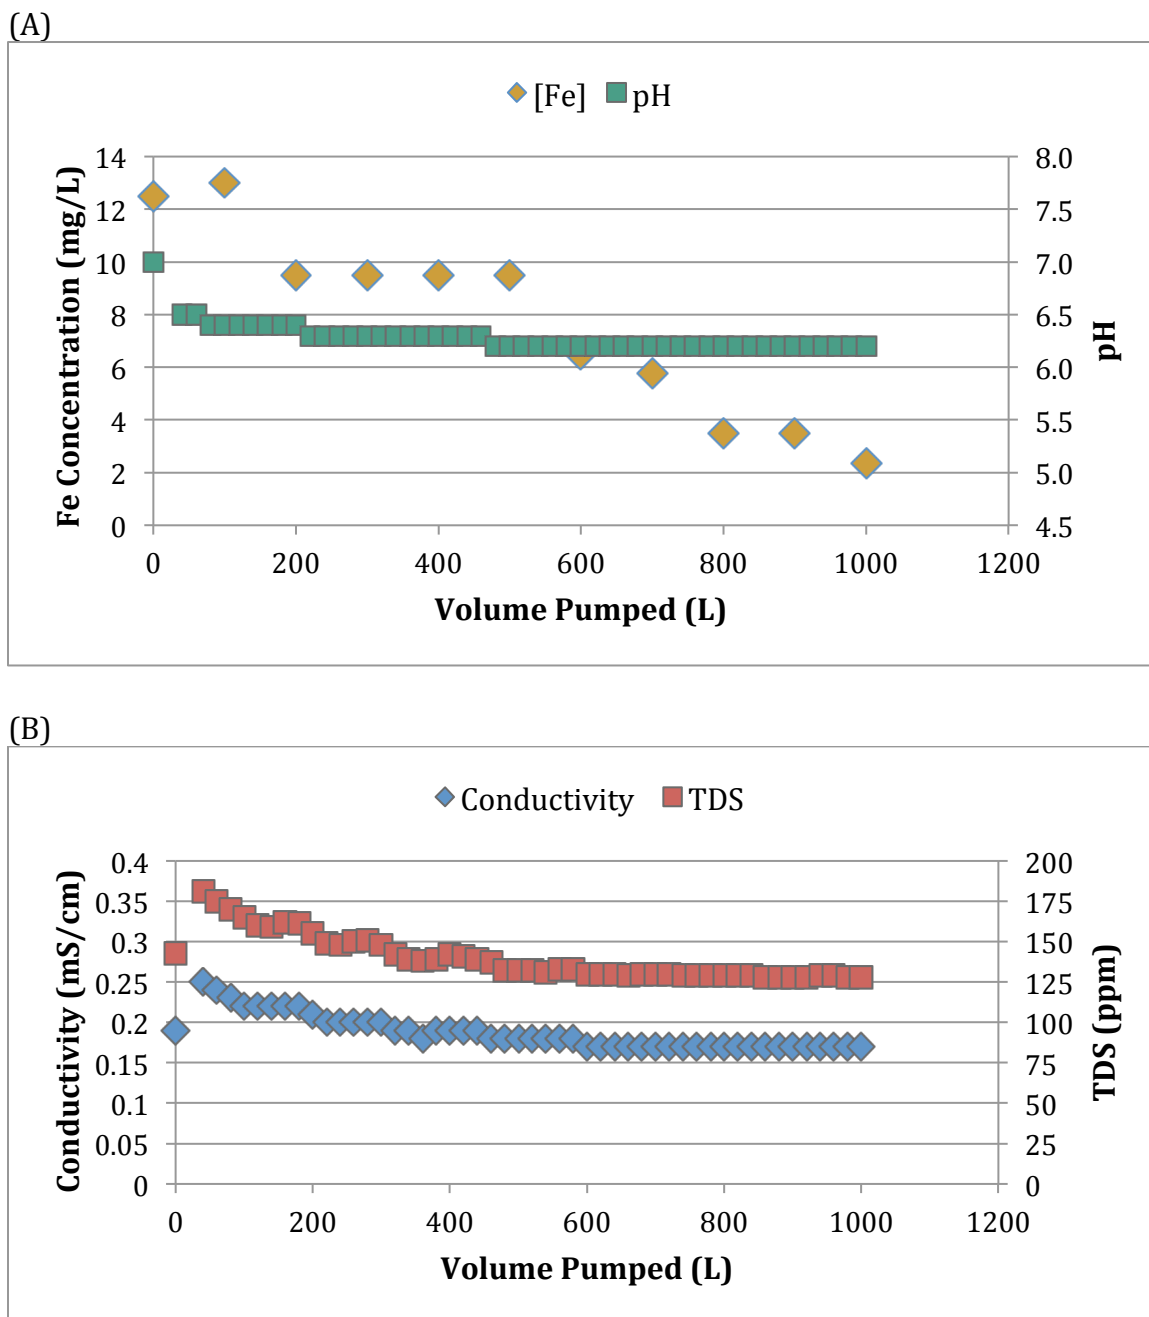
Figure 26. Borehole 16 Test #1 pump test results (A) pH stabilizes at 6.2 and the last iron concentration measurement taken equals 2.33 mg/L. (B) Conductivity and TDS stabilize at 0.17 mS/cm and 128 ppm, respectively.

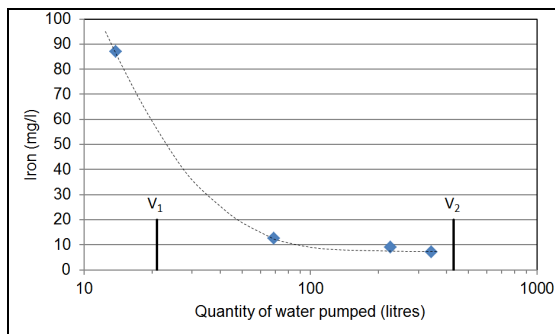
Example from a test on a non-corrosion resistant pump, West Africa (after Langenegger, 1994) :
Total iron concentration vs quantity pumped.
