**UNITED STATES DEPARTMENT OF TRANSPORTATION
NATIONAL HIGHWAY TRAFFIC SAFETY ADMINISTRATION**
1200 New Jersey Avenue SE
Washington, D.C. 20590

EA15-001
Air Bag Inflator Rupture

**REPORT OF TK HOLDINGS INC. PURSUANT TO PARAGRAPH 33.a
OF THE NOVEMBER 3, 2015 CONSENT ORDER**

June 30, 2016

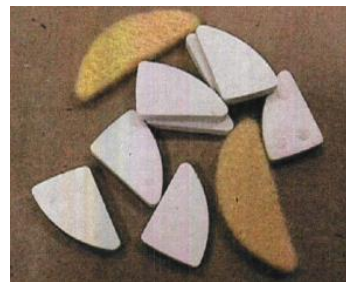
Information indicates that in October 1999, during module DV testing conducted at the vehicle manufacturer's facilities, a rupture occurred of the PSDI inflator. Takata and the vehicle manufacturer reviewed the issue, and Takata advised that the cause of the rupture was believed to be improper welding, which Takata committed to address.

Shark fin wafers (white) of the kind used in PSDI DV

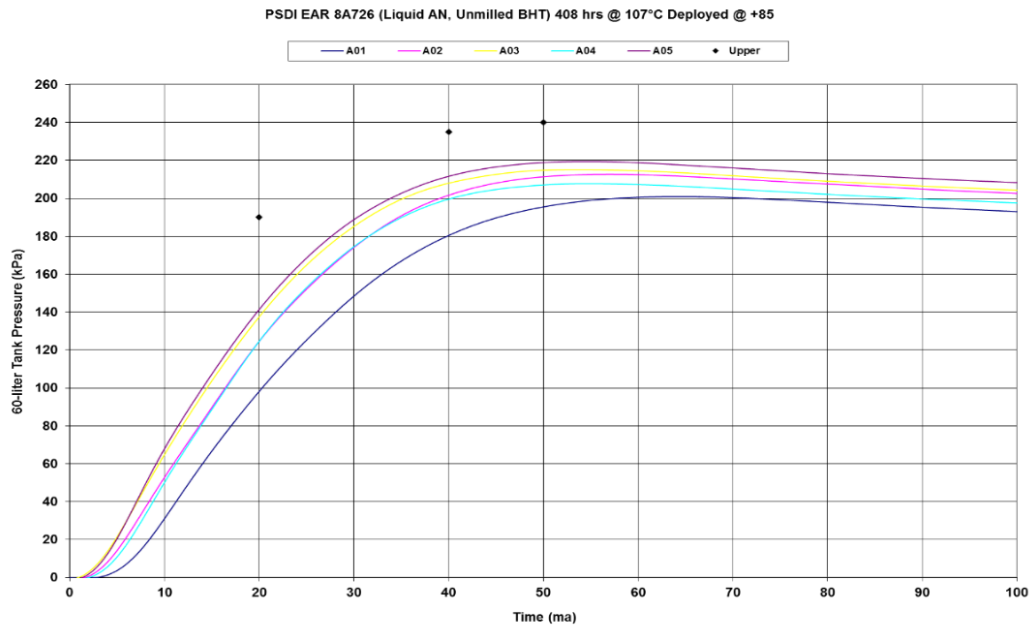
In November 2000, Takata conducted a complete re-test (delta PV) of all of the conditioning tests in the vehicle manufacturer’s validation testing specifications. This testing was complete by March 2001. The tests showed normal inflator behavior, with no ruptures. A few test data points were slightly above or below customer specifications, but Takata believed at the time and continues to believe that these test variations were not significant and that the inflator performed adequately. This re-testing was not disclosed to the customer.

Passing High Temperature Aging test performed on a PSDI inflator with unmilled BHT October-November 2000.

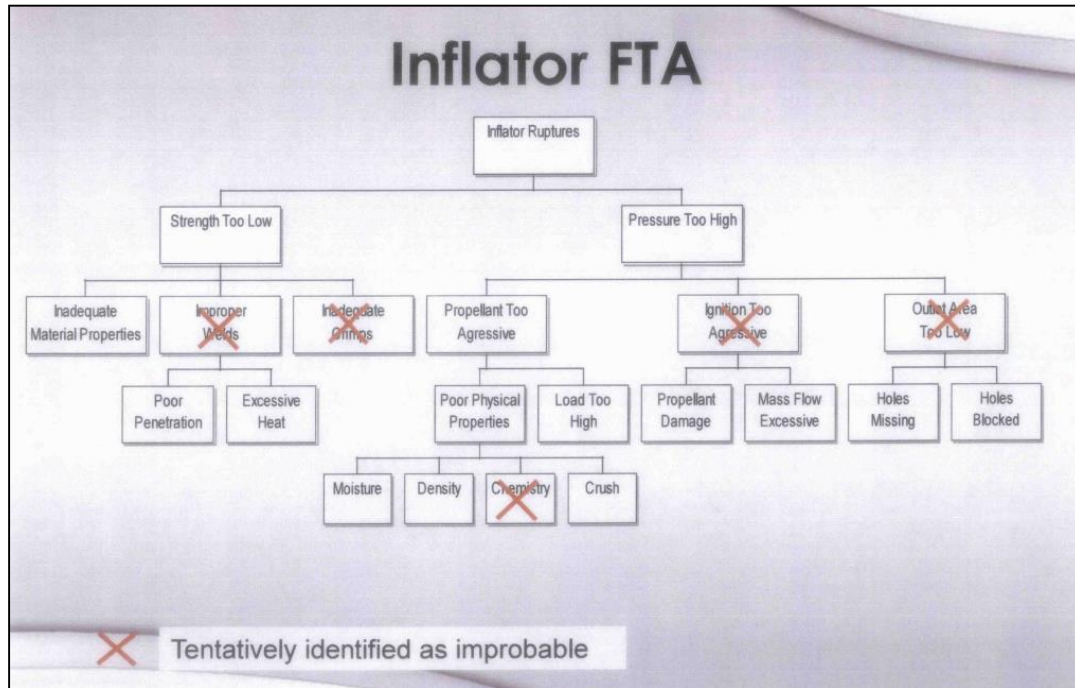
Fault Tree Analysis as of July 31, 2007

The FTA again showed the remaining potential causes as either insufficient cap structural strength or overly aggressive propellant during deployment, which could result from poor physical properties or too high of a load.

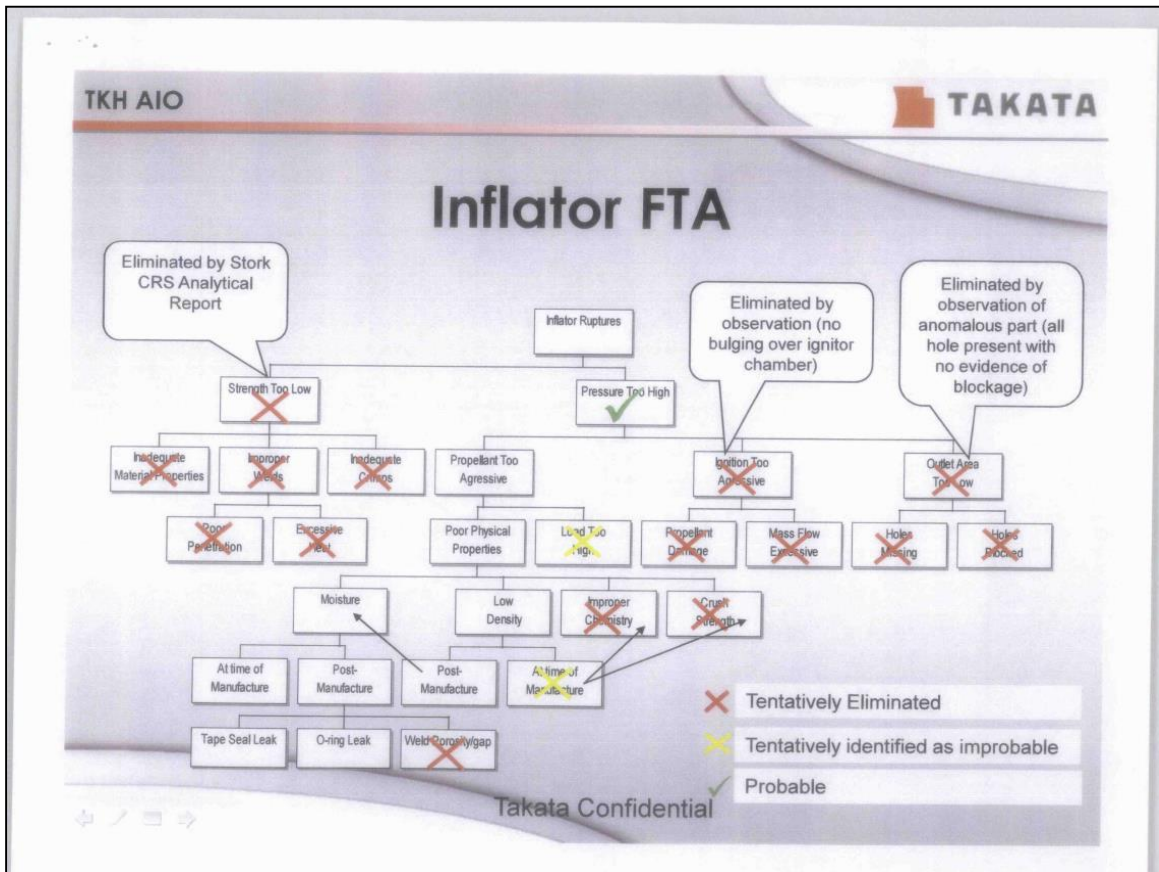
Fault Tree Analysis as of Aug 20, 2007

During the August 2007 briefing, Takata presented the chemical/metallurgical analysis conducted by an outside research organization of a fractured piece from an event inflator. The analysis concluded—based on the absence of material defects and the inflator’s conformance with specification—that the part fractured because it “experienced force . . . that exceeded its load-bearing ability.” Based on the analysis from the outside research organization, Takata tentatively eliminated the strength of the cap as being a possible cause of the rupture and identified the probable root cause as excessive burning pressure:

As the above chart shows, at that time, Takata identified low density as a potential root cause of the aggressive propellant. Takata stated that the most likely cause of the low density was degradation of the propellant through moisture intrusion occurring after the production of the propellant. At this point, Takata had “tentatively concluded” that the low density at the time of propellant production was “unlikely” because “wafers 100% inspected for weight and height at propellant manufacturing site eliminates low density wafers.”

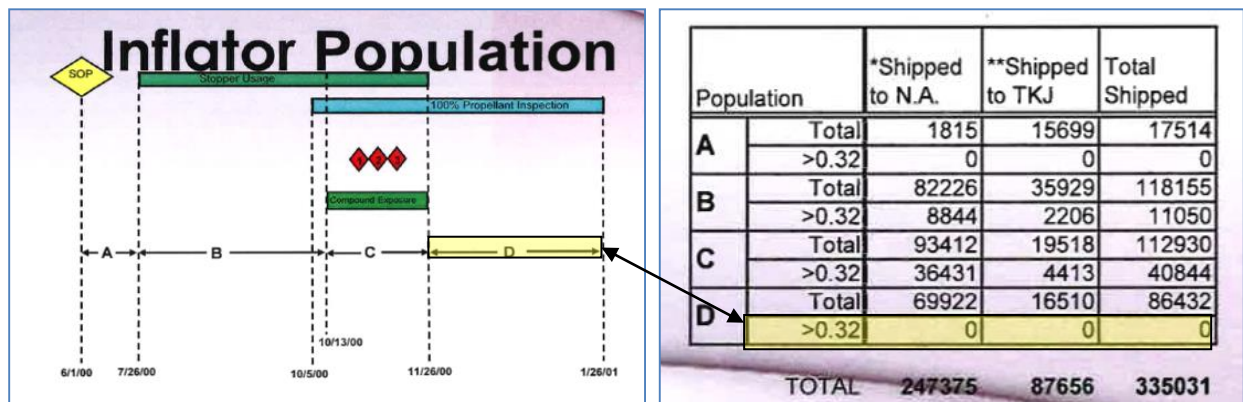
Takata’s moisture hypothesis prior to Event 4 had assumed (i) baseline moisture at 0.08 wt. percent when the propellant was manufactured, (ii) moisture increase of approximately 0.04 wt. percent during the 100-percent inspection period, and (iii) potential moisture increase of up to 0.25 wt. percent during the stopper application/tape seal period. Under these calculations, Takata surmised that inflators manufactured during the stopper application period alone, or more likely, during the combined stopper application and inspection period, could result in a moisture level above 0.32 wt. percent that could degrade the propellant. Takata had not believed, however, that inflators subject only to the 100-percent propellant inspection—like Event 4 and in “D” below—could exceed the 0.32 wt. percent moisture threshold.

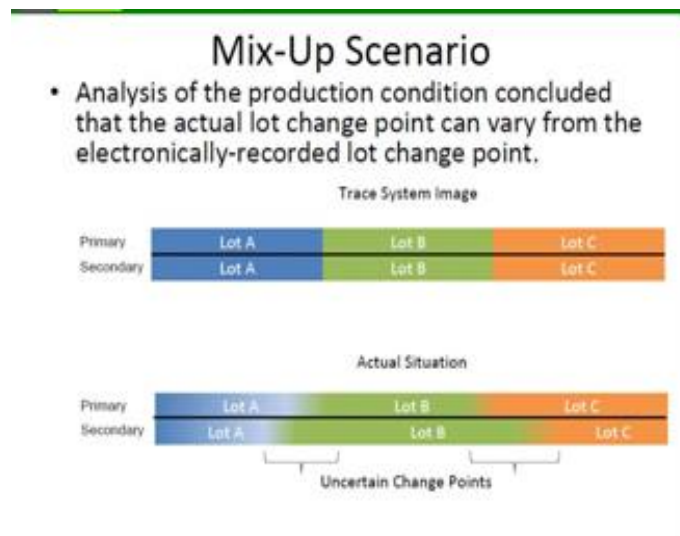
At the meeting, Takata explained the concept of the lot change point, which, in theory, is the moment inflator manufacturing switches from one lot of propellant to another. In Takata’s tracing system, these points appear to be precise and singular. However, in practice, the change points are somewhat imprecise and are not uniform (see below).

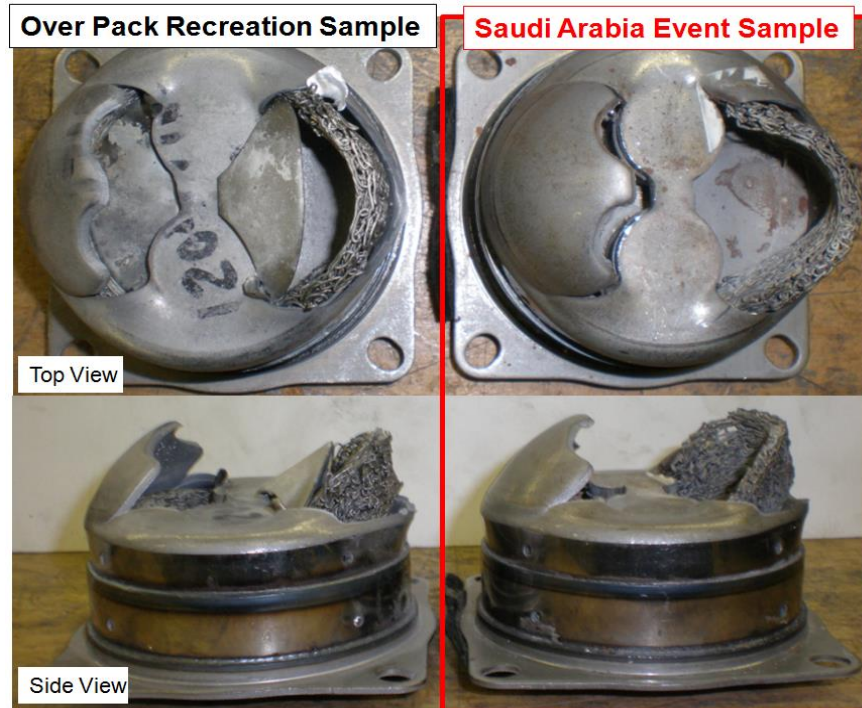
During the April 2012 meeting, Takata presented a hypothesis that the rupture resulted from a propellant overload. Takata hypothesized that, in the event an extra batwing wafer (five as opposed to four) was inserted into the disk press, the overpack would cause the propellant to crush and break. This breakage would increase the surface area of the propellant and the eventual burn rate, possibly leading to excessive internal pressure and rupture. While the propellant manufacturing line had a batwing height check to make sure extra propellant was not loaded during the time the event inflator was manufactured, Takata surmised that the height check might not catch the overpack when a batwing was broken. Takata tested its hypothesis by overpacking a secondary chamber of a sample PSDI inflator with an extra batwing and then deploying the inflator. The result was similar to that seen in the Saudi Arabia event (see photos, below). Takata concluded that the overpack hypothesis should be further analyzed. Takata also determined that the effect of Saudi Arabia's extremely hot environment warranted additional consideration and proposed testing the hypothesis by conducting heat cycle aging tests for both the propellant and the inflator.

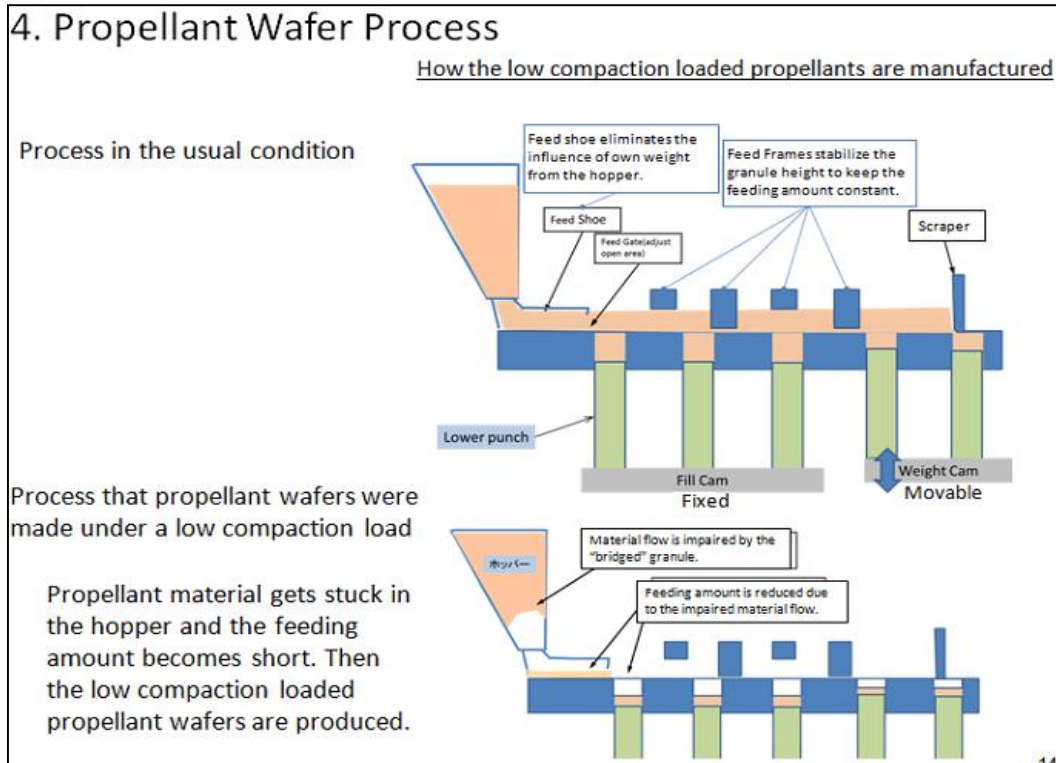
Takata explained how low compaction load propellant for PSPI and SPI inflators could have been manufactured. If an improper amount of propellant granules was loaded into the press, a "bridge" would be created that essentially clogged the flow of propellant and resulted in a decreased feed of propellant (see depiction, below). The compaction load during pressing varied based on the amount of propellant. Thus, the hypothesis was that decreased feed caused by the clog resulted in propellant lots with low compaction load.

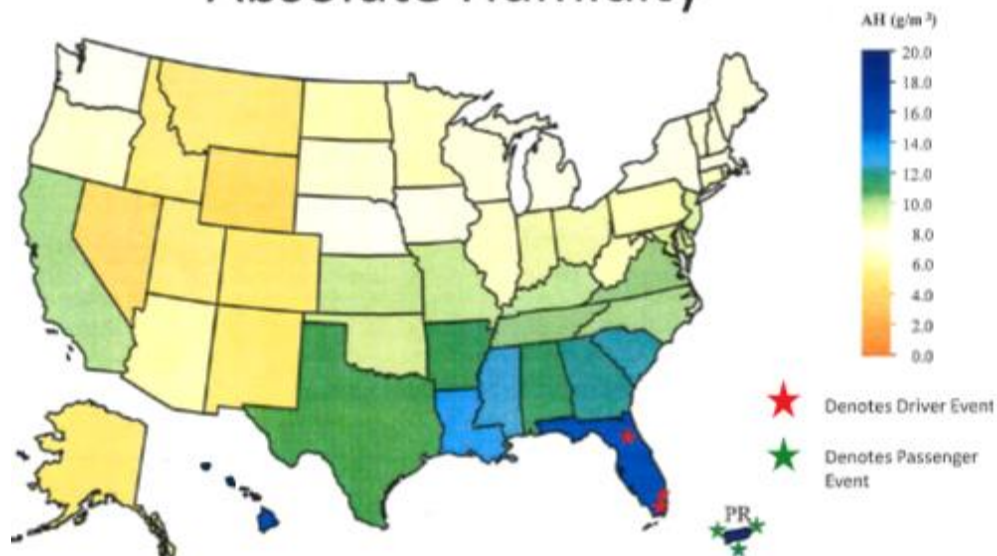
Beta Incident Location and Absolute Humidity

On May 20, 2014, Takata met with NHTSA regarding the six Beta Events that it was aware of at that time. Takata told NHTSA that its “tentative conclusion” was that the Beta Events “reflect a combination of long-term exposure to [HAH] environment[s], and processing issues that may have influenced aging stability.” In support of this “tentative conclusion,” Takata pointed to the location of the Beta Events that had occurred thus far.

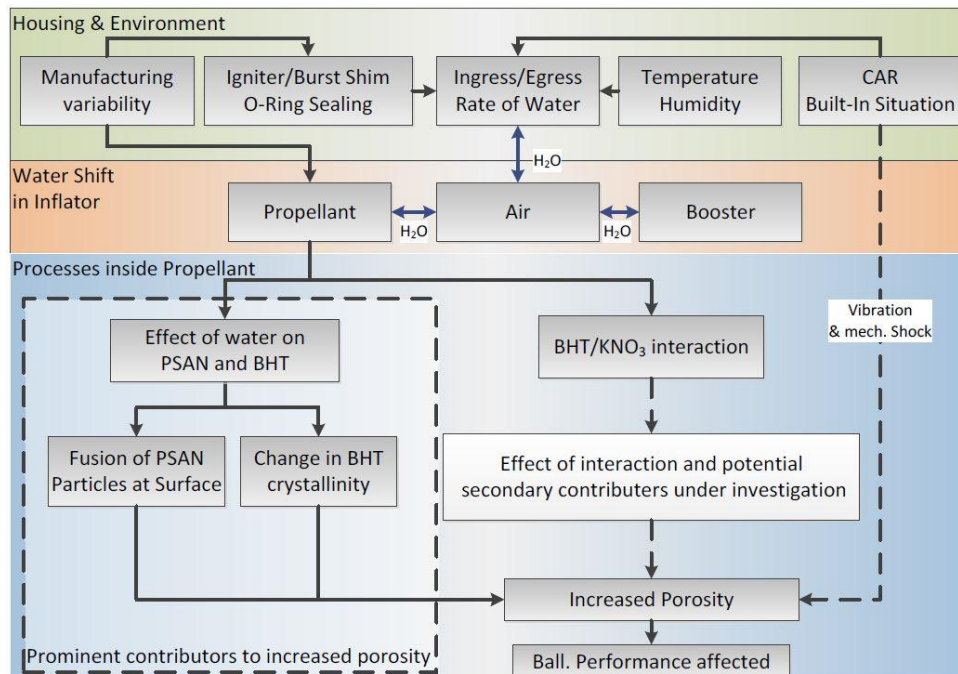
Fraunhofer’s February 2015 Fault Tree Analysis

As the fault tree analysis shows, Fraunhofer's investigations pointed to increased porosity in the propellant wafers, which, in turn, causes the propellant to perform more aggressively.

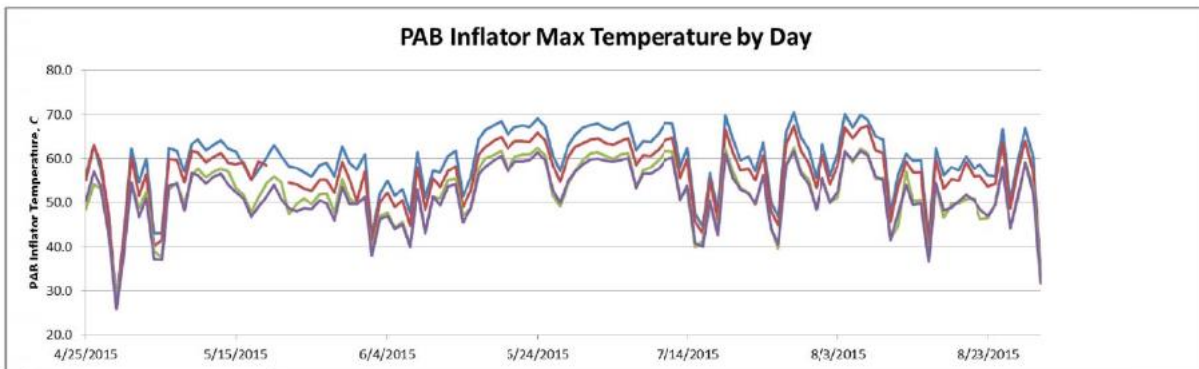
As can be seen, only in certain vehicle types does the interior temperature regularly rise above 60°C. This fact appears to be significant, Takata observed, because rupture rates appear to increase as the maximum passenger airbag temperature rises above 60°C, as show below:

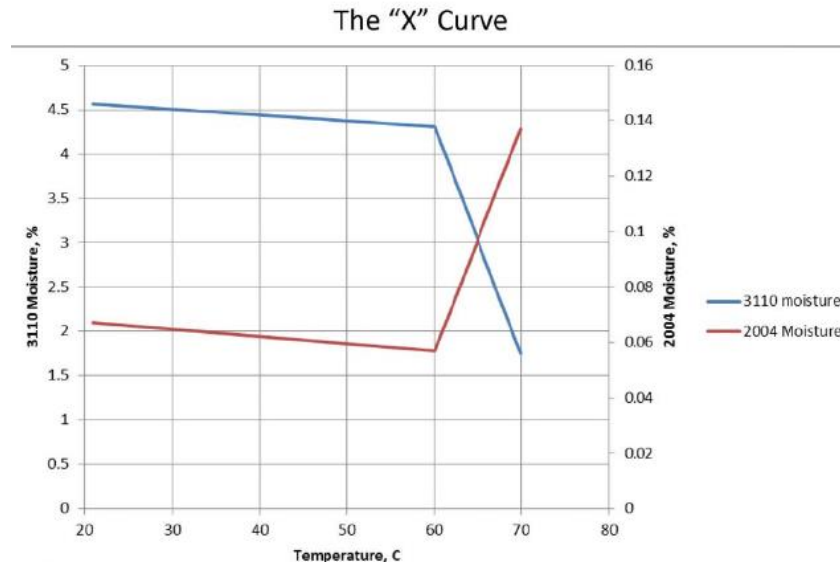
This increased rupture rate above 60°C, Takata observed, may be related to Fraunhofer’s findings regarding the tendency of 3110 propellant to absorb water preferentially, which tend to show that 3110 desorbs its water and transfers it to 2004 propellant at higher temperatures:

These observations indicate a rapid transition of moisture from the 3110 propellant into the 2004 propellant when temperatures exceed 60°C. This transition appears to occur more rapidly as the amount of moisture in the 3110 increases.

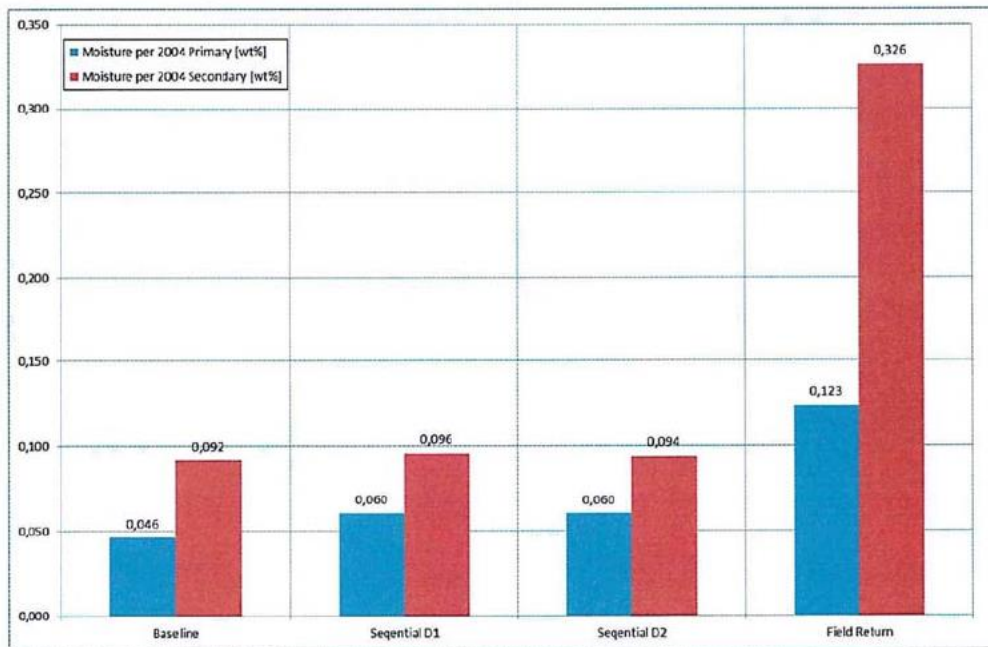
Fig. 3-3: Moisture inside inflators referred as moisture of 2004 propellant mass before / after USCAR sequential tests and data determined after life dissection from field return inflators (only Florida)

To answer this question, Fraunhofer studied the differences in inflators retrieved from the field from those put through vehicle manufacturer validation environments. Specifically, Fraunhofer compared PSPI inflators subjected by Takata to a series of vehicle manufacturer validation environments to those retrieved from Florida. In a report dated July 31, 2015 (and updated November 30, 2015), Fraunhofer described its findings. Overall, Fraunhofer found “remarkably lower concentrations” of moisture in inflators after vehicle manufacturer validation testing as compared to those seen in the field. As can be seen in Figure 3-3 below, the average moisture was far higher in the field return sample than after USCAR sequential testing.

Overall, environmental validation tests were able to generate only 50 to 60 percent of the average field return’s moisture in the primary propellant, and only 30 to 50 percent of the moisture in the secondary propellant. Fraunhofer found that the vehicle manufacturer validation tests “did not reach the levels [of moisture] high enough to generate the porous burning effect over time.”

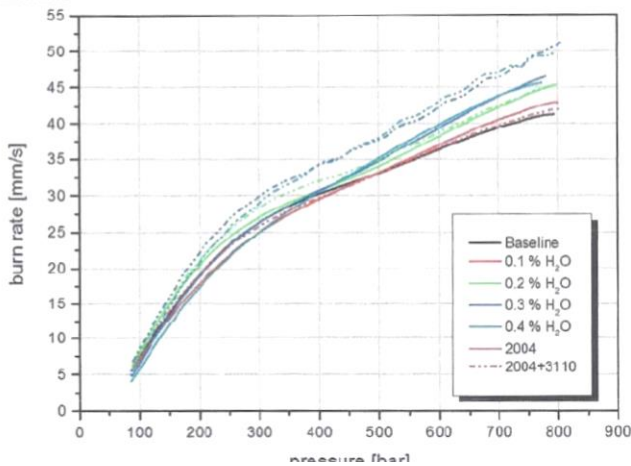
Artificial cycling tests

The report also discussed testing regarding the difference in burning characteristics between field returns and propellant put through artificial cycling tests conducted by Fraunhofer intended to recreate porous burning. As can be seen in the Fraunhofer chart below on the left, increased moisture due to artificial cycling results in a roughly uniform increase in burning rate across the entire range of pressures. The Fraunhofer chart on the right, by comparison, shows what is seen in the field: a highly non-uniform increase in burning rates that is exhibited only in the high pressure ranges.
