THE DEVELOPMENT OF A LOW-COST, LEAD FREE WELLPOINT DRILLING
SYSTEM FOR USE IN HOUSEHOLD WELL SYSTEMS IN COASTAL AREAS OF
MADAGASCAR

A Thesis Submitted to the Graduate Faculty
of Mercer University School of Engineering
in Partial Fulfillment of the
Requirements for the Degree

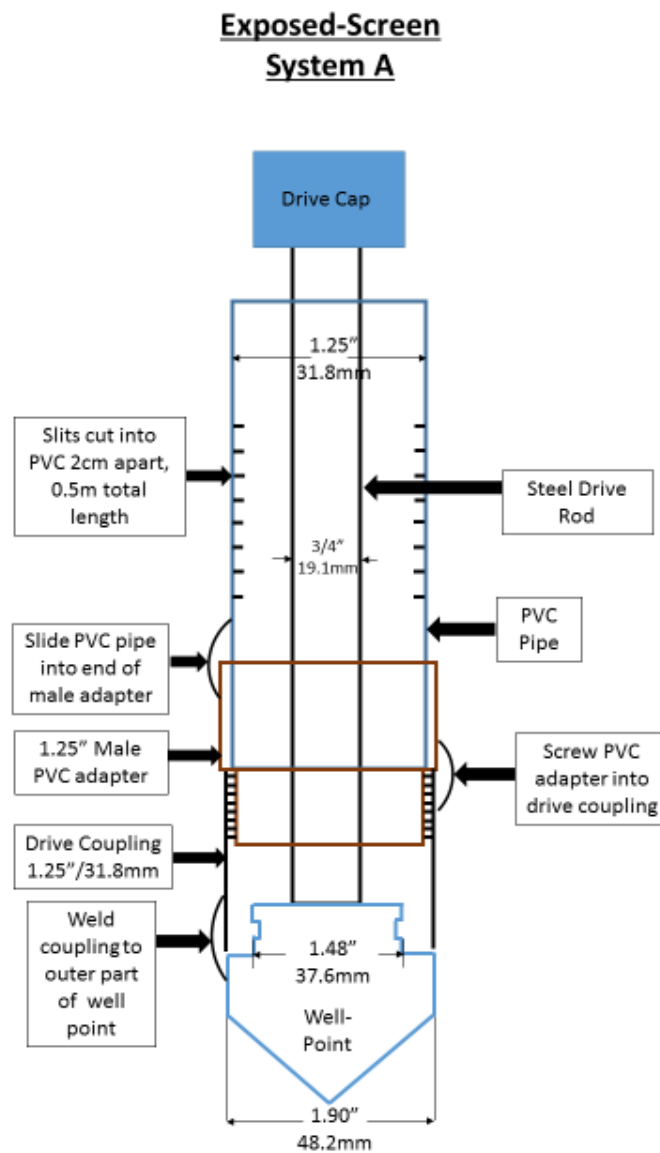
Figure 6. Diagram of Exposed-Screen System A

In Exposed-Screen System A, a 31.75 mm (1.25 in.) diameter PVC pipe was attached to a 31.75 mm (1.25 in.) diameter drive coupling and well-point by way of a male PVC adapter. The drive coupling and well-point were welded together. A 19 mm

(0.75 in.) diameter steel rod was placed inside the PVC pipe to drive the well-point into the ground. Slots were cut into the PVC pipe 30 cm above the male PVC adapter. *Figure 6* shows a diagram of Exposed-Screen System A.

Three Exposed-Screen prototypes were constructed. As with the Cased System, the well-point was tapered (in this case to 48.2 mm (1.9 in.)). A 31.75 mm (1.25 in.) diameter drive coupling was welded to the outer edges of the well-point so that the drive coupling and the outer edges of the well-point were flush. The riser pipe was a 31.75 mm (1.25 in.) diameter Schedule 20 (200 psi) PVC pipe. The 31.75 mm (1.25 in.) diameter PVC was connected to a 31.75 mm (1.25 in.) diameter male PVC adapter. PVC cement was used to bond the PVC pipe to the PVC adapter. The PVC adapter was screwed into the 31.75 mm (1.25 in.) diameter drive coupling. During well installation, a 0.75 in. diameter steel rod was placed inside the 31.75 mm (1.25 in.) diameter PVC pipe and used to hammer Exposed-Screen System A into the ground. (See *Figure 6*, page 21 for a complete diagram of Exposed-Screen System A).

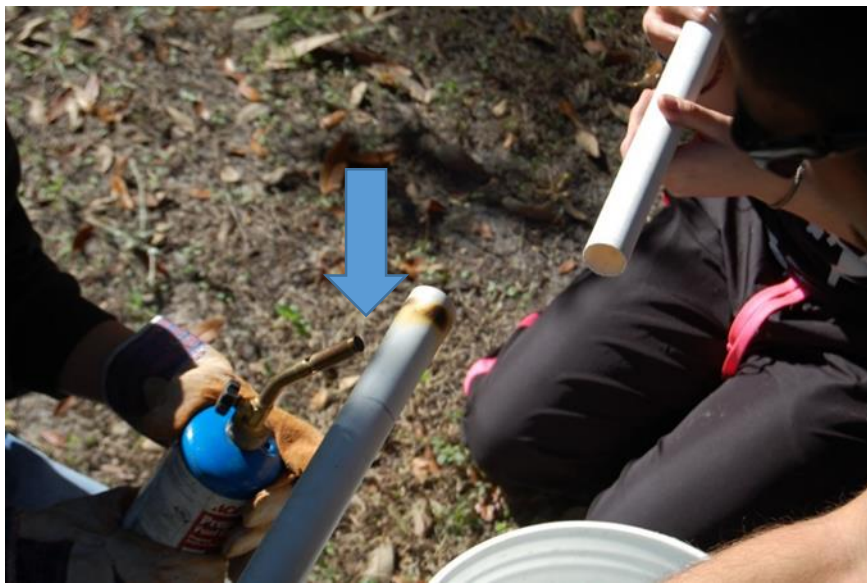
Figure 9. Heating a PVC Pipe

31.75 mm (1.25 in.) diameter PVC pipe that was being driven into the ground was exposed and had only a polyester screen sleeve around the slots to help filter out large sand particles. The belled-end of the PVC pipe was made by heating the end of a pipe and fitting another piece inside the heated piece. *Figure 9, Figure 10, and Figure 11* show the process of belling out a PVC pipe.

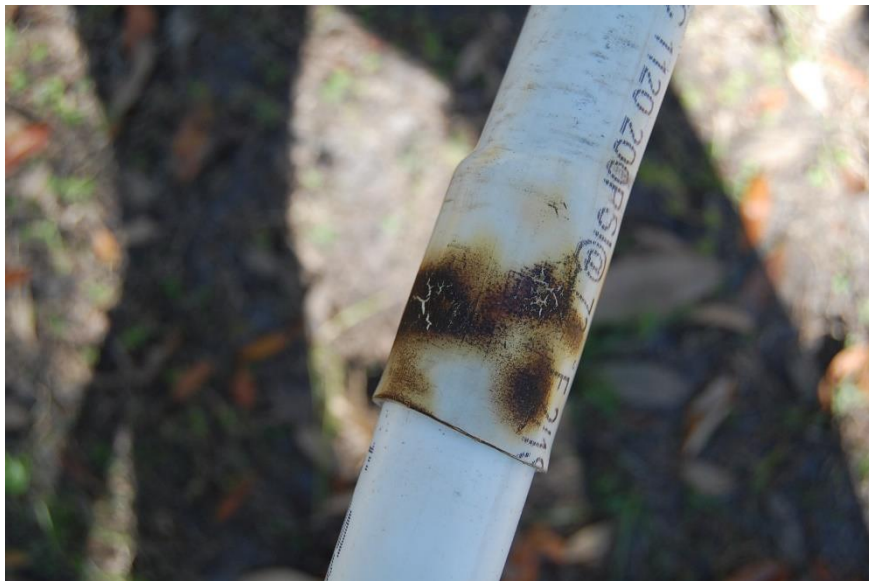
Figure 11. Final Result of Belling-Out a PVC Pipe

Once the belled-end was made, a separate piece of 1.25 in. diameter Schedule 20 (200 psi) PVC pipe was fitted into the belled-end. This reinforced the belled-end of the PVC pipe during the hammering process. In addition, four self-drilling screws were

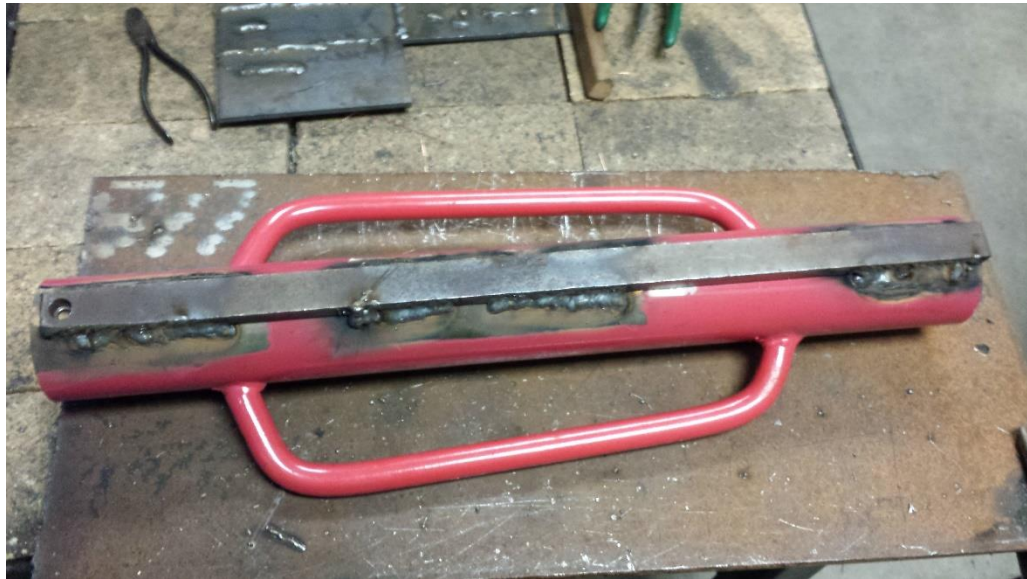
Figure 15. Modified Drive Hammer

The fence post driver had two handle bars, one on either side of the driver, that were angled at about 45 degrees to help with the ergonomics of the hammer. The drive hammer weighed approximately 16 lbs when first purchased. Additional weight was added to enable the fence post driver to hammer the pipe down farther with each stroke, easing stress off the user from pounding. Two three-pound square steel rods were welded

on opposite sides of the fence post driver to counterbalance the weight. The total weight of the fence post driver, with the additional steel rods welded to the driver was 9.5 kg, or approximately 20 lbs. *Figure 15* shows the modified drive hammer.

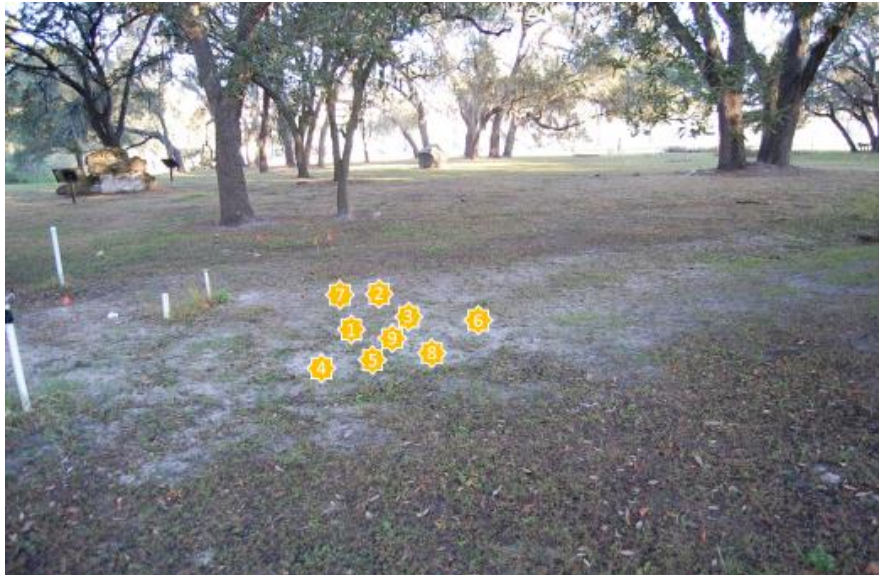
Figure 16. Relative Location of Each Well in the Geopark

A total of nine wells were drilled. The drilling process began with selection of a suitable area and coring down to a certain depth before installing the system. *Figure 16* shows the relative locations of each well in the GeoPark.

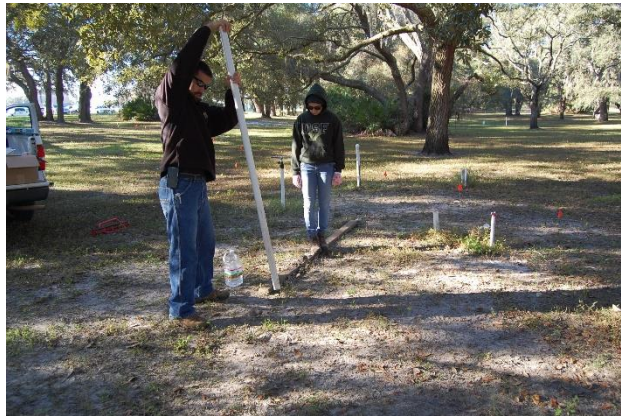
Figure 18. Coring of Well #1

Well #1. The Cased System drilling method was used for Well #1. Well #1 was first cored to a depth of about 1.5 m (4.92 ft), then the well casing was installed and hammered into the ground an additional 2 m (6.56 ft). Coring of Well #1 can be seen in *Figure 18*.

At about 0.5 m (1.64 ft) the soil appeared to be fine sand with black organics. At 1 m (3.28 ft) the sand became clumpy and turned gray, and at 1.45 m (4.76 ft) the soil was a muddy, light gray sand. At this point the drilling system appeared to reach the top of the water table and could no longer be cored.

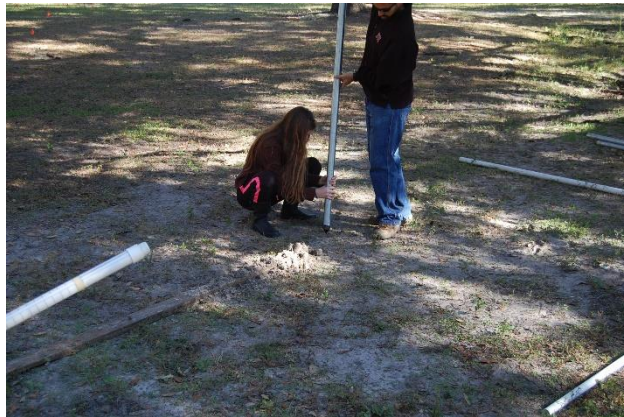
Figure 19. Installation of Cased System

Next, preparations were made to install the outer drive casing of the Cased System. The well-point was wrapped with paper to make sure that it would not fall out of the drive casing as it was being set into the hole. At this point only the well-point with the outer drive casing was set into the hole. Installation of the Cased System can be seen in *Figure 19*. The 1 in. diameter riser pipe was installed after the well was drilled to the desired depth.

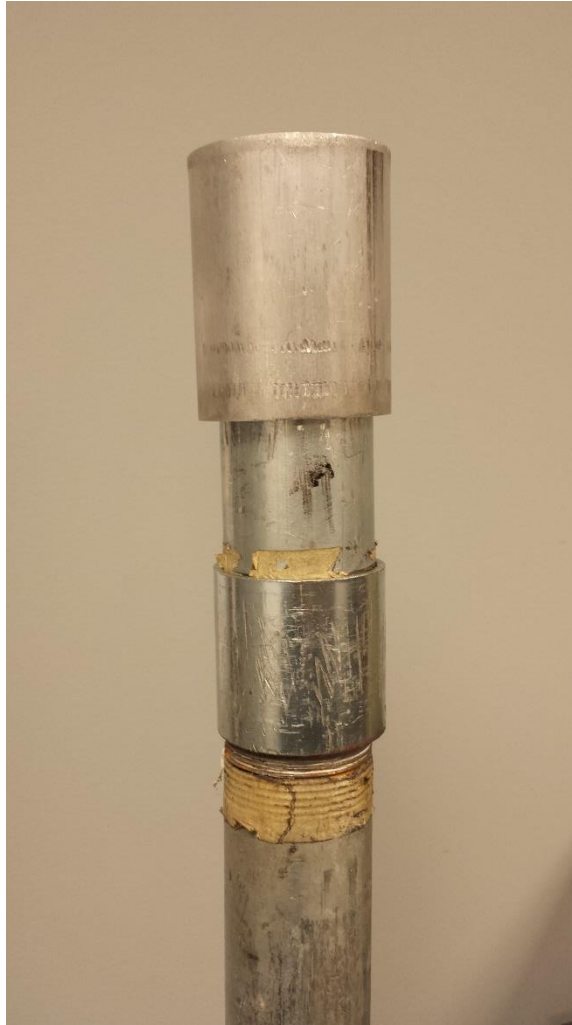
Figure 20. Drive Casing and Buffer Pipe for Cased System

Buffer pipes were used during the hammering process to help protect and ease the stress on the threads and allow the outer drive casing to sit flat and flush on the well-point. Two buffer pipes, one on each end of the main drive pipe, were connected. The drive cap sat on the top buffer pipe — an 11.5 cm (4.5 in.) length pipe — and the buffer pipe connected to the drive casing by way of a drive coupling. The bottom buffer pipe, a 30.5cm (1ft) length pipe, sat evenly on the well-point and was also connected to the drive casing by way of a drive coupling. *Figure 20* shows both the drive cap and the top buffer pipe.

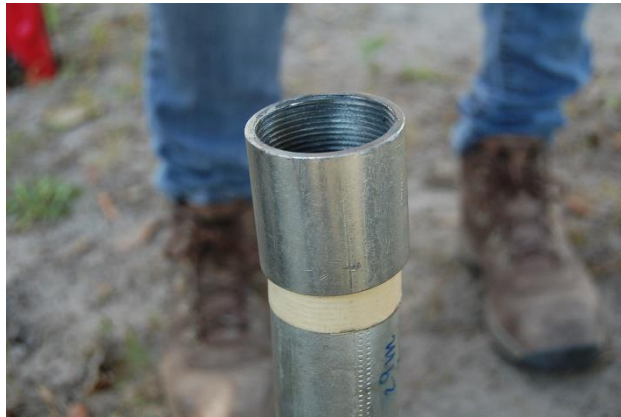
Figure 21. Bent Drive Coupling

Hammering with the Cased System commenced at about 1.5 m (4.92 ft). This included the measurement of the drive coupling and the well-point, which was about 11 cm (4.33 in.). At 2.55 m (8.37 ft) hammering was paused to add an extra 1.5 m (5 ft) of drive casing. The connection between the drive coupling and the buffer pipe (the top section of the pipe that was being hammered) and the first 10 ft section pipe were examined. As *Figure 21* shows, the connection between the buffer pipe and the 10 ft

section pipe was bent at the drive coupling. The buffer pipe was removed and the 5 ft section was added. Plumbers' tape was wrapped around the male threads of the 5 ft drive casing to add support and stability between the threads. Hammering was restarted and eventually stopped at a depth of 3.5 m (11.15 ft).

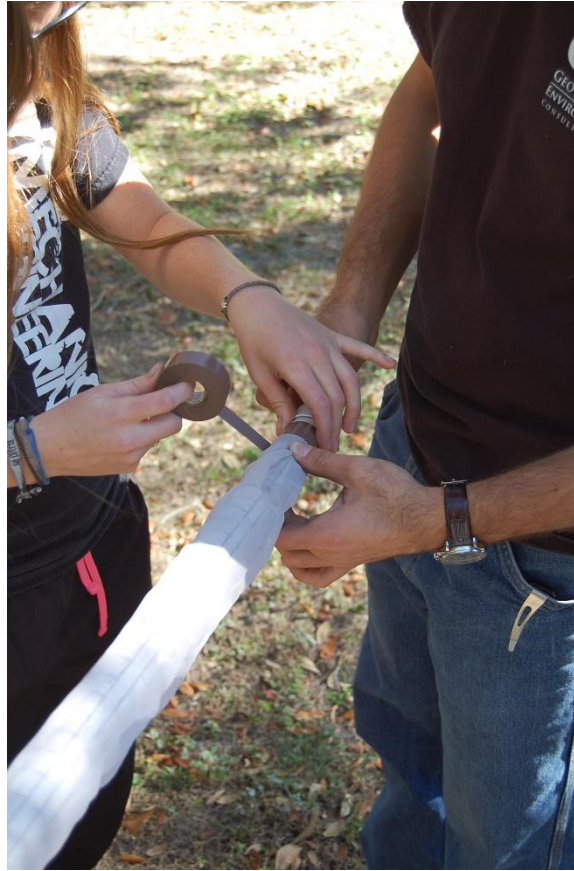
Figure 22. Preparation of the Riser Pipe

A total of 2 meters (6.56 ft) of the 3.5 meters was hammered using the Cased System. After hammering was complete, a 25.4 mm (1 in.) diameter PVC riser pipe was prepared so that it could be inserted inside the outer drive casing (which would be withdrawn from the ground) and used to pump water from Well #1. A half meter of slots were cut into the riser pipe, and a breathable polyester fabric sleeve was wrapped over the slots to keep large sand particles from entering into the riser pipe. (Too much silt/sand in the riser pipe could prevent water from being pumped out). Then the sleeve was taped on both ends with electrical tape. *Figure 22* shows the preparation of the riser pipe.

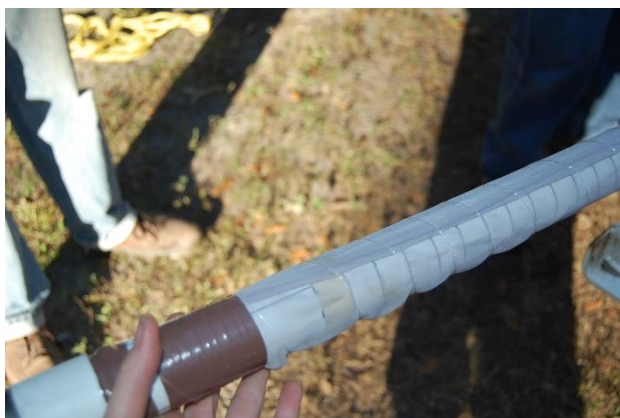
Figure 23. Completed Preparation of Wellscreen

Exposed-Screen System A utilized a Schedule 20, (200 psi) pipe. This type of pipe was used because it is similar to the type of pressurized pipe available in eastern Madagascar, and it is a cheaper type of PVC than Schedule 40 or Schedule 80 PVC. This PVC pipe was prepared by slipping a polyester breathable sleeve over the cuts on the pipe and taping each end of the sleeve with electrical tape. Fishing line was then wrapped around the breathable sleeve in order to keep the sleeve from being torn as the pipe was being hammered down. *Figure 23* shows the completed wellscreen.

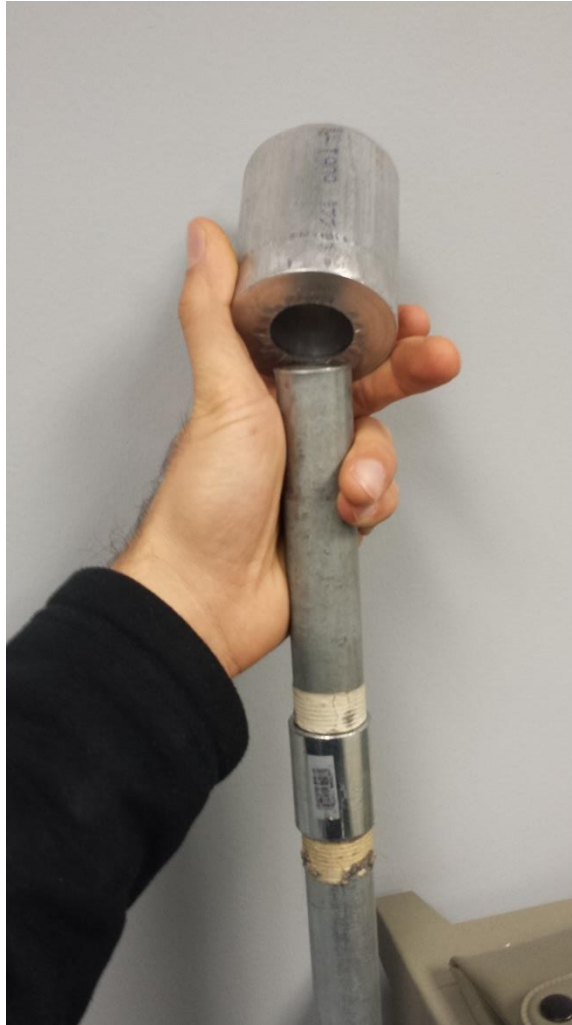
The drive pipe for Exposed-Screen System A was prepared by adding two pieces of buffer pipe to the drive pipe (one on each end of the main drive pipe) in order to protect the threads during hammering and also to give the end of the pipe a strong, firm end piece to strike the well-point. The top buffer pipe that fit inside the drive cap was 15.2 cm (6 in.) and the bottom buffer pipe was 30 cm (11.8 in.). There was concern that the threads would not be strong enough if placed in direct contact with the well-point during the hammering process. *Figure 24* shows the top buffer pipe and drive cap for Exposed-Screen System A.

Figure 24. Top Buffer Pipe and Drive Cap for Exposed-Screen System A

Plumber's tape was used on all male connections on the drive pipe to help support the threads. The same drive cap was used in the hammering process that was used for Well #1. Because the drive pipe was much smaller than the outer drive casing of Well #1, extra material had to be wrapped around the top buffer pipe so that the drive cap could fit securely on the buffer pipe.

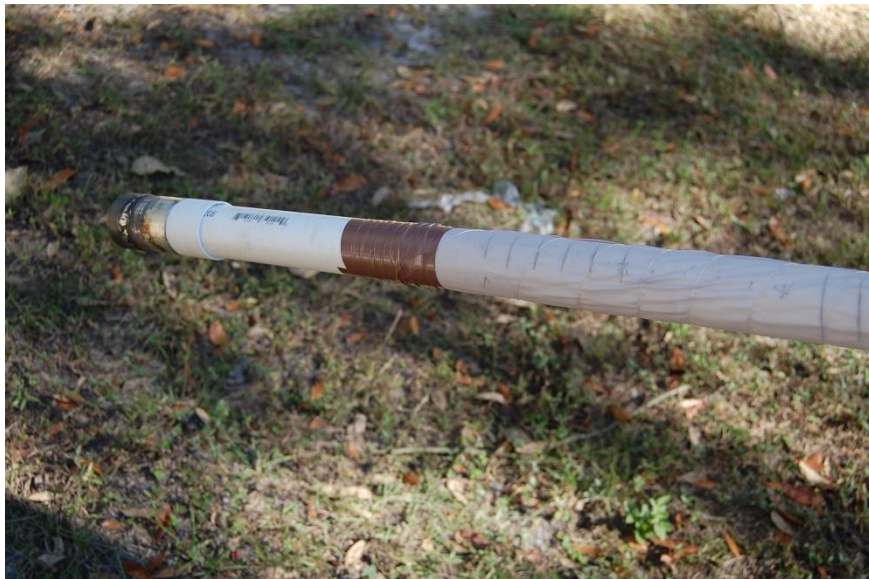
After coring, modifications were made to the Exposed-Screen System A Method. This time, the second method for cutting slots was implemented on the Schedule 20 (200 psi) PVC pipe. The slots were a half meter in length. A breathable polyester sleeve was used to cover the slots as in the last three wells; however, the sleeve was not taped directly below the male adapter as it had been on the first drilling attempt with Exposed-Screen System A. *Figure 25* shows a picture of the modified system.

Figure 25. Modified System for Well #4 with New Slot Cutting Method

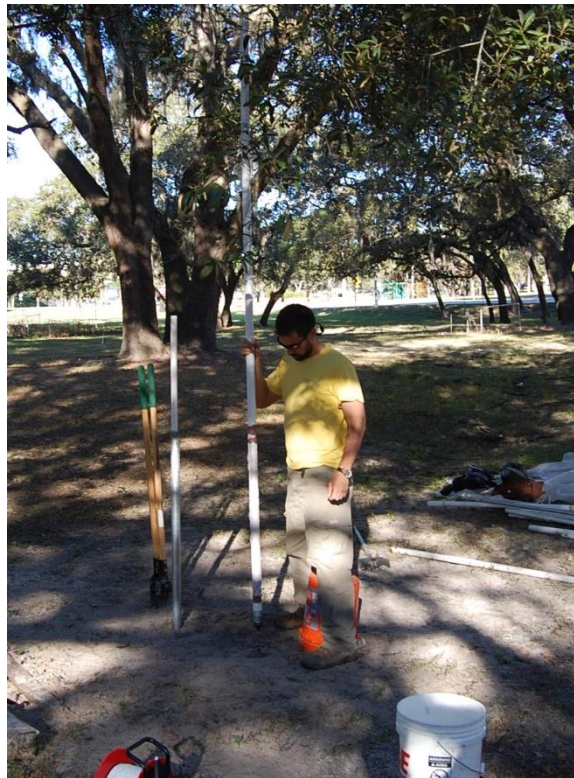
The pipe was notched out, both above and below the slots, so that the fishing line would have a more secure grip while holding down the breathable sleeve. As with the other wells, the sleeve was slid over the slots in the pipe, and electrical tape was used to secure the sleeve. This time the bottom portion of the sleeve was taped immediately above the male adapter, instead of below the slotted screen. This would help prevent the sleeve from being pushed up. Fishing line was wrapped around the sleeve and secured in both the top and bottom notches. The ends of the fishing line were also taped both above and below the slots to help the fishing line stay in place and to keep it from getting caught up during the drilling process. *Figure 26* shows the system complete and ready to drill.

Figure 26. Finished Exposed-Screen System A

Hammering commenced at 1.1m and was stopped at 2.35 m. The well-point on the end of the pipe broke off at the threads of the male adapter that screws into the drive coupling and well-point. The remainder of the pipe was pulled up and examined. This was the last well drilled during the first trip to Tampa.

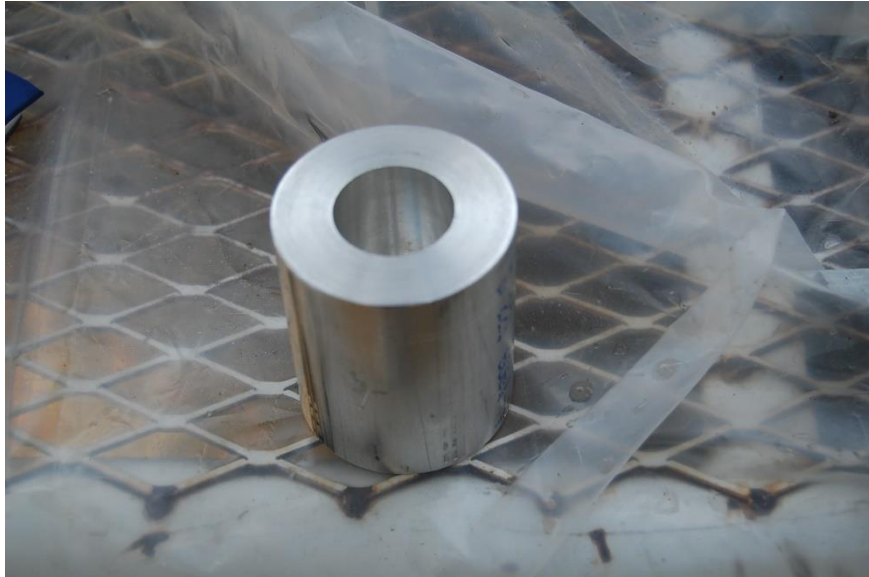
Redesign of Exposed-Screen System A. To prevent the well-point from breaking off at the coupling connection, a modification to the 1.25 in. diameter PVC pipe was discussed and developed so that the end of the system closest to the well-point would be stronger and more reliable in the drilling process. This new system was called Exposed-Screen System B. To help with the stability of the hammering process, a new drive cap was created to fit the diameter of the 0.75 in. diameter drive pipe. Like the first two drive caps, this drive cap was made out of aluminum but was bored deeper and with a smaller diameter for greater stability during the hammering process. *Figure 27* shows the new drive cap.

Figure 27. New Drive Cap for 0.75 in. Drive Pipe

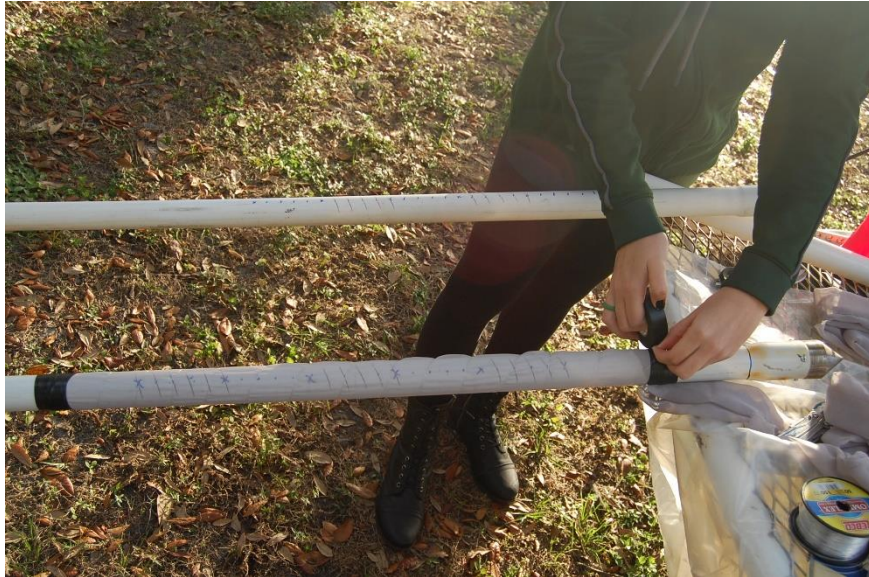
The first system utilized a Schedule 40 (370 psi) pipe. Since the Schedule 40 pipe is a stronger pipe, it was chosen to be used first. If that drilling was successful, then a Schedule 20 (200 psi) PVC pipe would be used. Similar to the preparation process for Exposed-Screen System A during Wells #4 and #5, slots were cut on Exposed-Screen System B using the method developed in the field. It was important to keep the same type of preparation process as before so that it would be easier to narrow down the problems if there were any. A polyester sleeve was then fitted over the slots. The sleeve was made for a 1.25 in. diameter pipe instead of a 1.5 in. diameter PVC pipe. The sleeve was sized correctly and fit comfortably over the PVC pipe but was not taped directly below the belled-end side of the pipe. The pipe was also notched out above and below the cuttings on the pipe, and fishing line was wrapped around the notches and the sleeve. Then electrical tape was used to secure the fishing line in the notches on both sides of the slot cuttings. *Figure 28* shows the preparation of Exposed-Screen System B for Well #6.

Figure 28. Preparation of Exposed-Screen System B

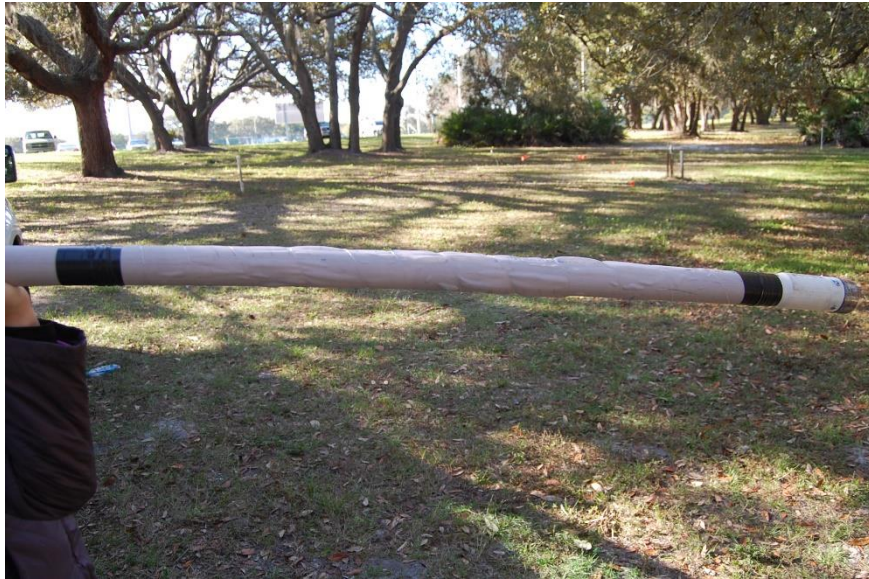
strength of the Schedule 20 pipe would hold up as well as the Schedule 40 pipe. PVC cement was added to help secure the breathable sleeve and was applied on both ends of the sleeve and in between the slots on the screen. Like the notches, the breathable sleeve was started immediately after the belled-end and extended down to 15 cm past the cuttings that form the screen. Fishing line was applied after the PVC cement dried and the screws were again filed down on the belled-end. *Figure 29* shows the Schedule 20 PVC pipe for Well #8 prepared and ready.

Figure 29. Schedule 20 PVC Pipe for Well #8 Prepared and Ready

The PVC pipe was inserted into Well #8, and hammering commenced at 1.2 m (3.94 ft). During the hammering process, the drive hammer was lifted only 15 cm for each stroke. Like Well #7 the strokes were made shorter. Hammering stopped at 2.1 m

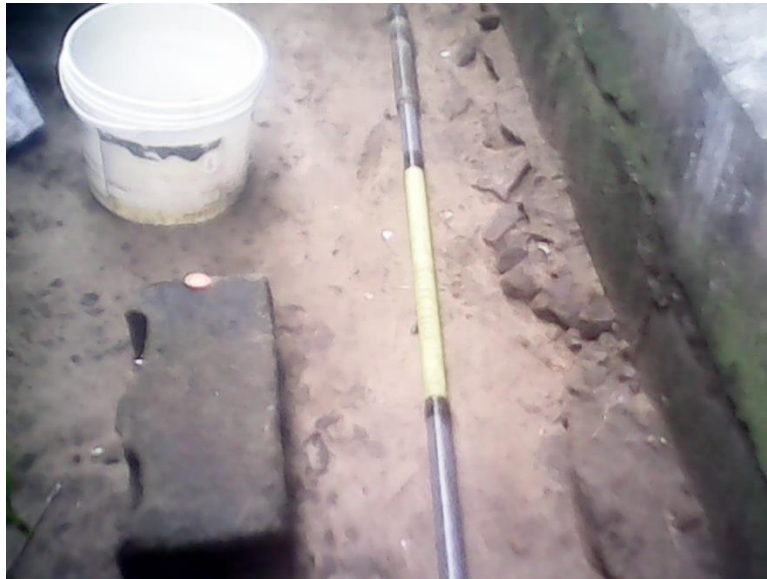
Both systems were built and assembled by the driller. *Figure 31* shows a picture of one of the completed systems.

Figure 31. Completed Madagascar System

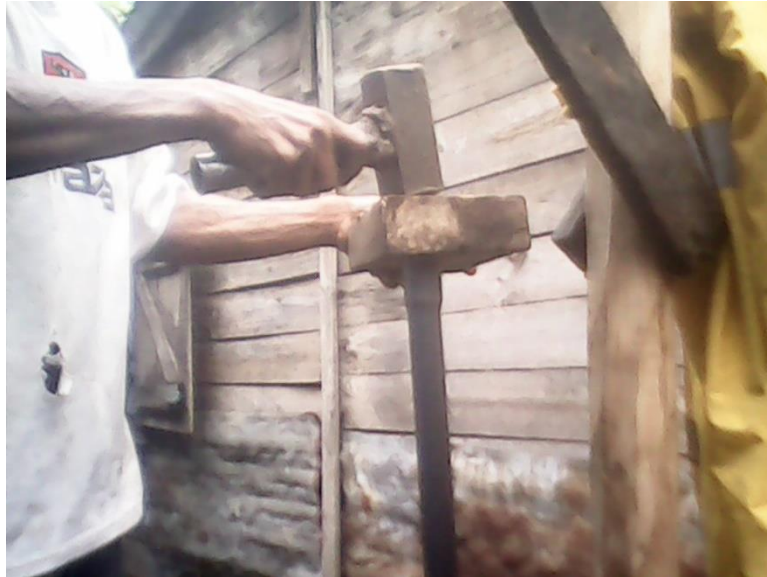
The same drilling process was used for both wells. The two wells were first cored down to the water table. Next, a GI pipe was inserted and hammered down farther. (Note: this step in the process was not in the drilling instructions sent over to Madagascar.) The GI pipe was retracted, and the Madagascar System was inserted. The driller hammered on the PVC pipe (See *Figure 32*).

Figure 32. Hammering on PVC Pipe

This was not in the drilling instructions and was believed to be a miscommunication.

Only about three-quarters of the PVC pipe was hammered because the driller did not use the drive pipe as instructed. After receiving new instructions a few days later, the driller used the drive pipe to help complete the drilling of both wells. Finally, delayed by extreme weather conditions, the driller deconstructed the well and examined it one week later according to the deconstruction instructions that had been sent (See Appendix F).

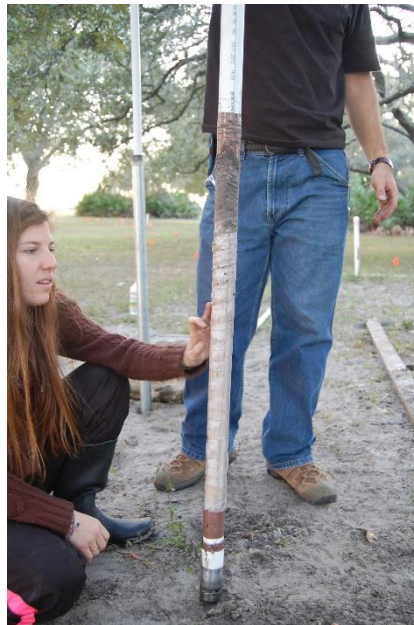
Well #2. Wells #2-5 utilized Exposed-Screen System A. Well #2 was drilled and then removed from the ground successfully. Exposed-Screen System A showed no visible damage to the exterior, and the breathable sleeve was still in place, as it had been before the well was drilled. *Figure 33* shows Exposed-Screen System A for Well #2 after drilling.

Figure 33. Exposed-Screen System A after Drilling

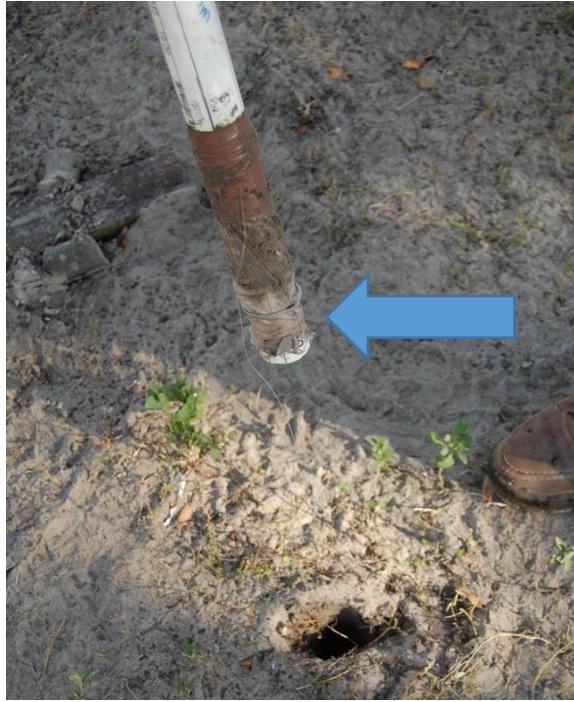
Well #3. During the drilling of Well #3, Exposed-Screen System A broke off at the first cut that started the screen, and the lower 70 cm of the PVC pipe was lost. This system was the same one that had been used in Well #2. The break at the beginning of the

screen was a clean break. Two causes were thought to have contributed to the breaking of the PVC pipe:

- 1) lack of strength in the screen area of the PVC pipe (the three sets of slots made in the pipe with 1.5 cm between each set of slots had decreased the pipe's strength and stability); and
- 2) constant pressure from repeated hammering during Well #2 drilling may have weakened the stability around the screen area of the PVC pipe. To prevent another such breakage, a new set of slots was cut, with the goal of strengthening the PVC pipe so that it could be hammered into the ground.

Figure 34. Break in Pipe for Well #3

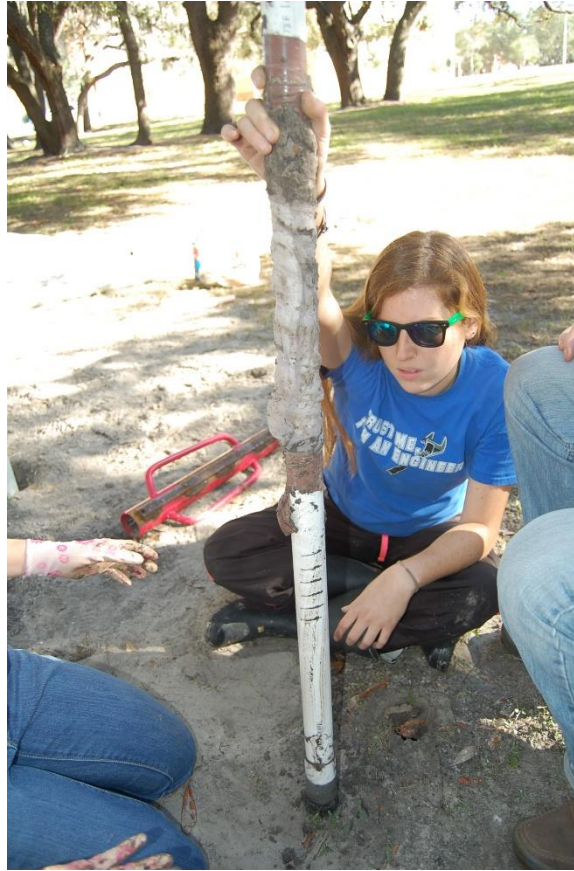
Well #4. Well #4 posed no problems during the coring and hammering phases. However, after removing the pipe from the ground, it was observed that the breathable sleeve was noticeably pushed up. (*Figure 35* shows the sleeve pushed up for Well #4). This likely happened during the hammering process. The sleeve had been made for a 1.5 in. diameter PVC pipe; and the pipes that were being used in drilling were 1.25 in. in diameter. However, when the sleeve was taped to the pipe, the tape may have been too high up on the pipe, which could have allowed dirt or roots to get under the tape during the drilling process. The pipe for Well #2 did not have a pushed up sleeve; however, in that case the sleeve had been taped closer to the male PVC adapter.

Figure 35. Sleeve Pushed Up on Well #4

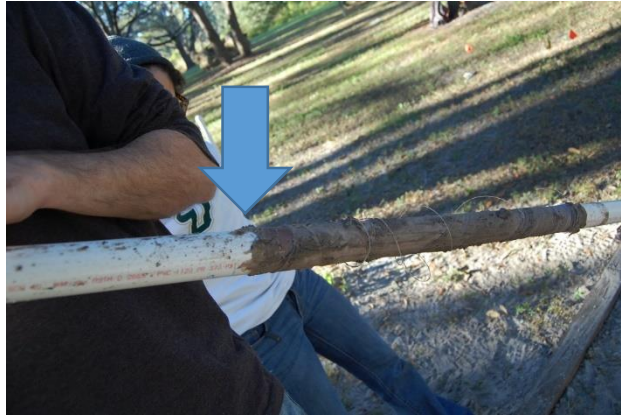
Well #5. A few changes were made in the preparation for the installation of Exposed-Screen System A for Well #5. A stronger pipe was used (Schedule 40 pipe instead of Schedule 20), notches were made above and below the screen, and the bottom portion of the breathable sleeve was taped directly above the male adapter. Toward the end of the drilling process, the end of the pipe broke off at the threads of the male adapter, and the drive coupling and well-point were lost. Upon retrieval of the system, the sleeve was found to be pushed up over the screen, similar to what had happened in Well #4. Pictures of the remaining drilling system are shown in *Figure 36* and *Figure 37*.

Figure 36. Failed Screen on Well #5

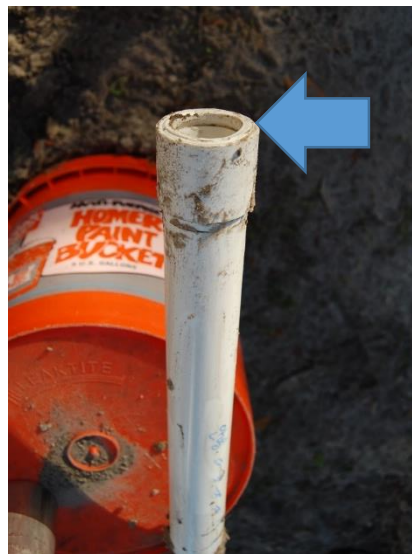
Figure 37. Failed PVC Adapter on Well #5

Addressing the matter of weak connection between the PVC male adapter and the drive coupling began with the threads on the male adapter. The threading on the adapter removed about half of the thickness of the threaded portion of the male adapter, making the threaded portion of the PVC adapter the weakest connection between the PVC riser pipe and the well-point. Additionally, the constant hammering on the nub of the well-point may have placed stress on the components to which the well-point was connected, i.e., the male adapter and the stainless steel drive coupling. The combination of the stress from hammering the well-point and the weak connection between the drive coupling and the PVC male adapter may have caused the pipe to break at the threads of the male adapter during the hammering process.

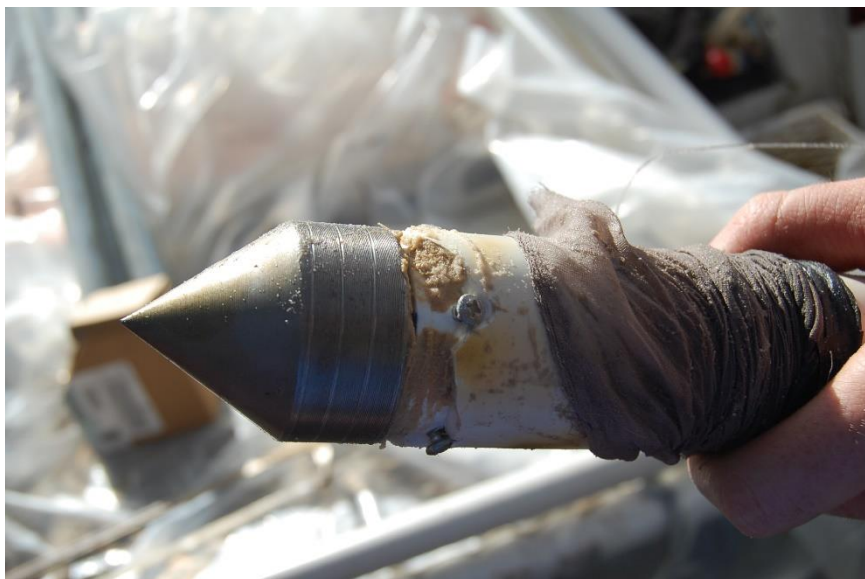
Wells #6 and #7. Wells #6 and #7 were hammered using Schedule 40 PVC pipe with Schedule 20 on the inside of the belled-end. The same modifications that were used during drilling of Exposed-Screen System A were made on the new Exposed-Screen System B in Well #6. The goal of Well #6 was to test the new drilling system to make sure that the well-point did not break off from the rest of the system. Analysis of the PVC pipe pulled from the ground after drilling Well #6 revealed that the Schedule 40 portion of the belled-end was not broken off but was cracked at the edge, where screws had been placed to hold the well-point in place. Additionally, there was a piece chipped off in approximately the same area. It appeared that the screws may have caught on something as the pipe was being hammered down, which may have put pressure on the screws and caused the screws to bend and crack the PVC. Also, the tape did not hold, and the sleeve was pulled down towards the well-point. Analysis of the interior of the PVC pipe showed mud and soil filled the bottom portion of the PVC pipe. *Figure 38 and Figure 39* show the remains of Exposed-Screen System B for Well #6.

Figure 38. A Broken and Cracked Belled-End

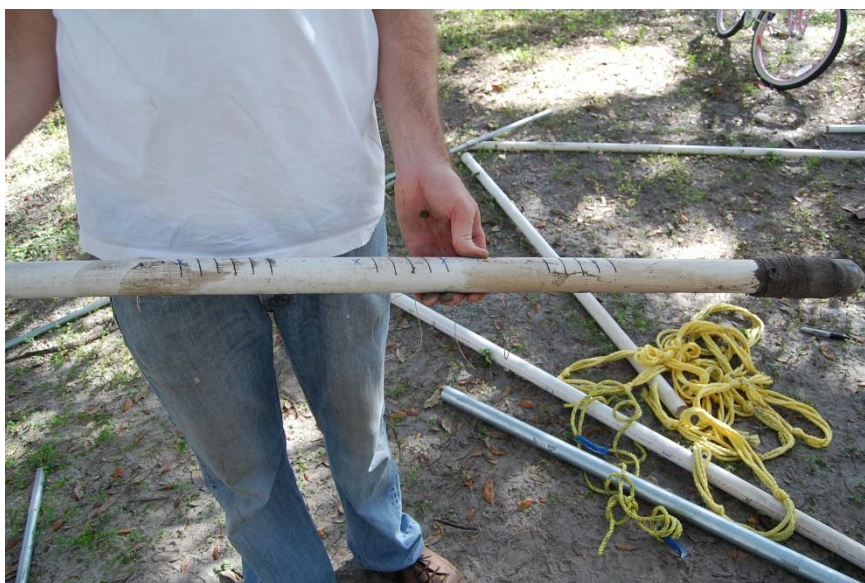
Figure 39. Sleeve Pulled Down on the Belled-End

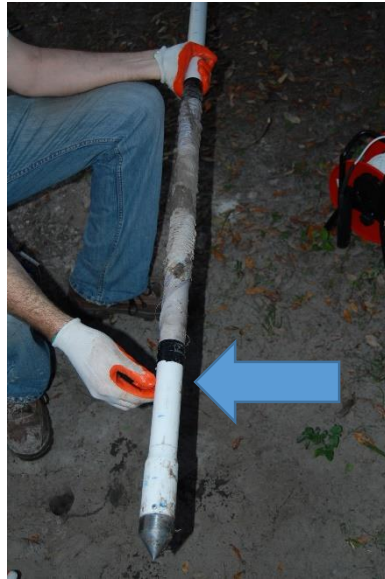
immediately after the belled-end. In addition, the pan-head screws on the belled-end of the pipe were filed down, and shorter strokes were made during the hammering process. After the hammering process the system was removed. No visible external damage to the belled-end of the pipe or the screws was found; however, the sleeve was pushed up about 0.25 m. *Figure 40* shows the PVC pipe after drilling Well #7.

Figure 40. PVC Pipe after Drilling Well #7

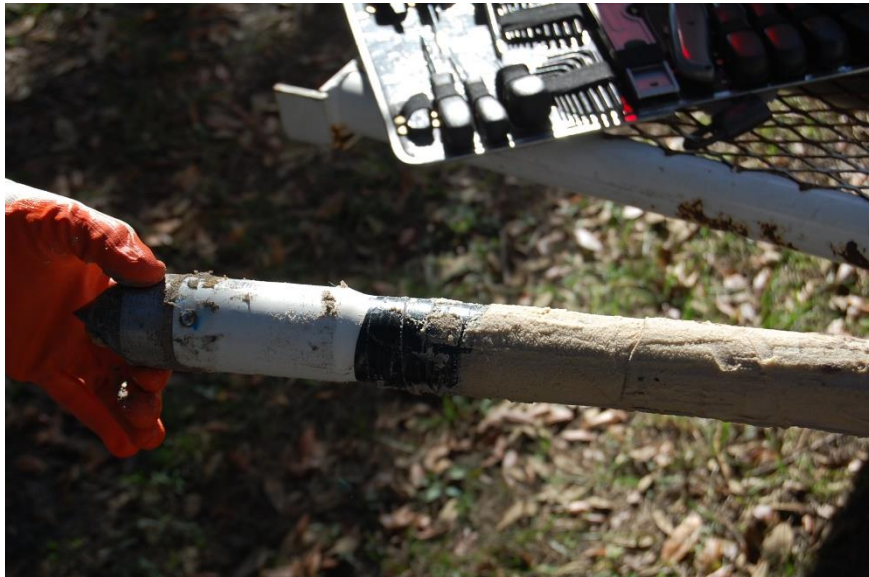
breathable sleeve. Additionally, the length of each stroke was set at 15 cm, to minimize vibration that could disturb the PVC where it is attached to the well-point. After hammering, the PVC pipe was removed from the ground. There appeared to be no external damage to Exposed-Screen System B, and the sleeve remained in the same location as it was before the drilling process began. *Figure 41* shows Exposed-Screen System B after drilling Well #8.

Figure 41. Exposed-Screen System B after Drilling Well #8

Fortunately, the last two drillings were successful (Wells #8 and #9). The sleeves were not pushed up, and there was no external damage to the PVC pipes. This was attributed to two factors: 1) use of shorter hammer strokes, and 2) taping and PVC cementing the end of the sleeve directly under the belled-end or PVC adapter (depending on the type of system used). The shorter hammer strikes took longer to get the pipe down;

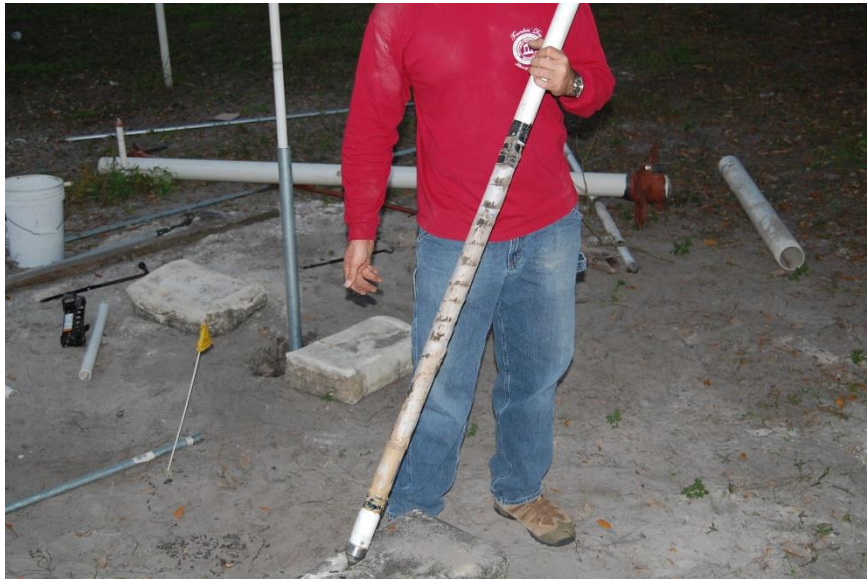
The goal for Well #9 was to replicate, successfully, the result achieved in Well #8. The same preparations were made and the 15 cm stroke length was used during the hammering process. There was some difficulty removing the PVC pipe from the ground. Once removed, there was a noticeable amount of clay around the well-point area of the PVC pipe, which may have caused the difficulty in removal. The sleeve remained in

place and had not moved during the hammering process. *Figure 42* shows the PVC pipe after drilling Well #9.

Figure 42. PVC Pipe after Drilling Well #9

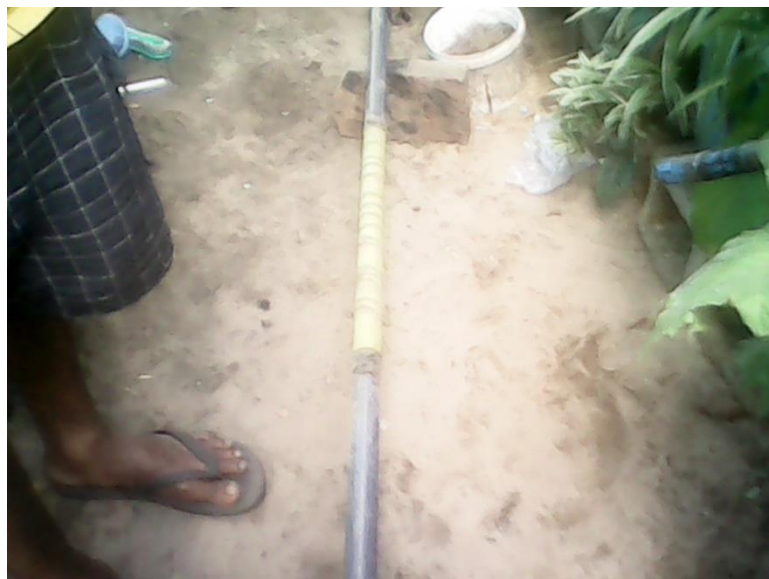
Deconstruction. Almost one week passed before the wells were deconstructed. Both wells were deconstructed and removed from the ground without any issues. The well-points for both systems were left in the ground, and the PVC pipes and GI drive pipes were examined. The breathable sleeves on both wells did not appear to have any damage and were not pushed up. The breathable sleeves were then removed and the slots on the PVC pipes were examined. Just like Wells #8 and #9 in Phase II, there appeared to be no damage to PVC pipes or the GI drive pipes. The PVC pipes of the deconstructed systems can be seen in *Figure 43 and Figure 44*.

Figure 43. PVC pipe of Well #1 of the Madagascar System

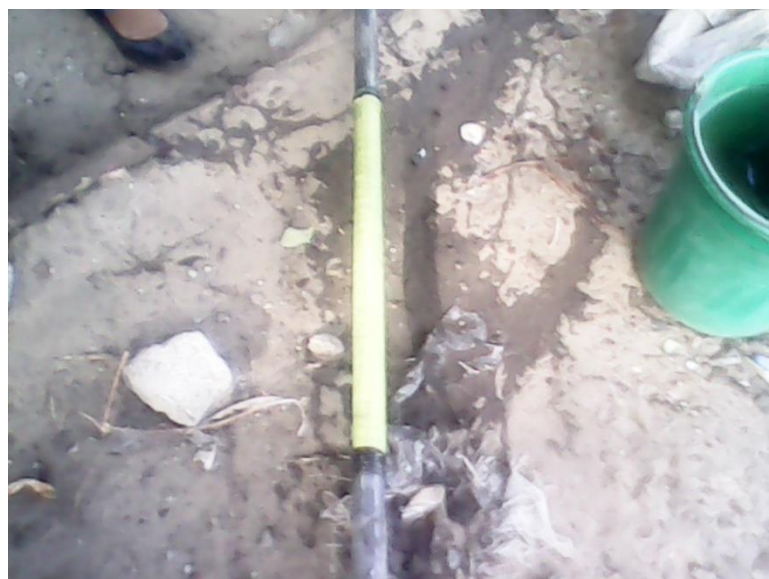
Figure 44. PVC pipe of Well #2 of the Madagascar System

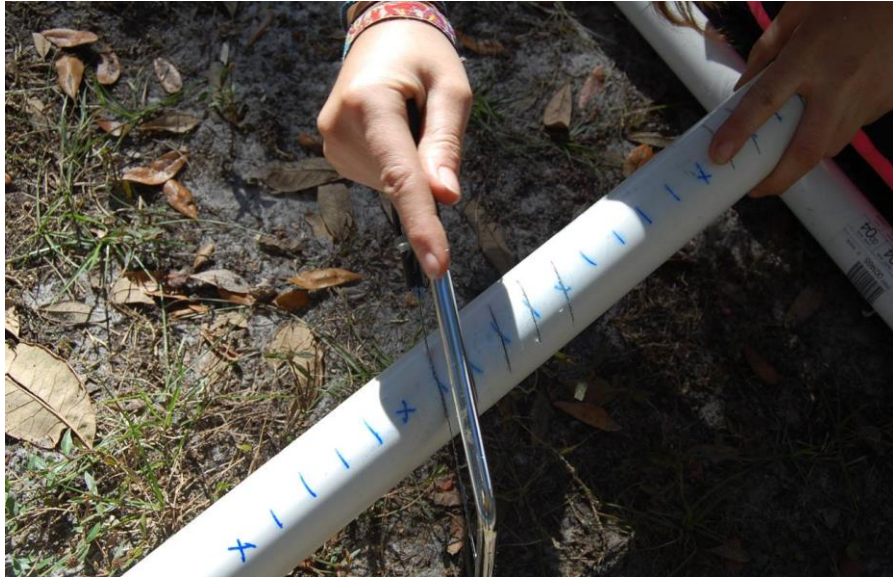
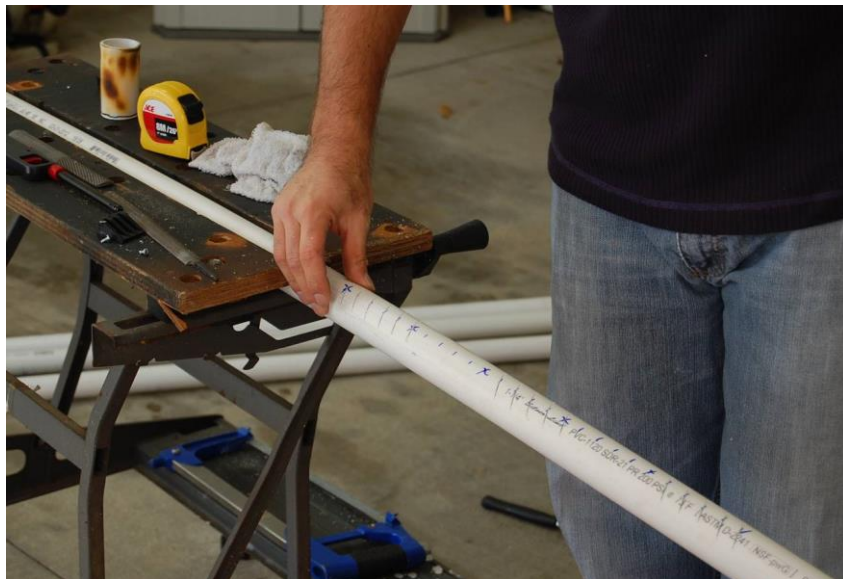
1. Coupez 50cm d'une cote de tuyau PVC de 6m (pour que le longeur total est 5m et demi).
2. Pour les fentes coupées:
 - a. Mesures 40cm de cote bas de tuyau PVC. A 40cm marque, en utilisant un scie, fait les fentes coupées en diagonale chaque 2 cm pour 10cm (c'est a dire, 5 fentes coupées). Voir photos ci-dessous. (NOTE: Fait attention que les fentes sont seulement $\frac{1}{4}$ or $\frac{1}{3}$ du diametre du tuyau – PAS PLUS que ca, or le tuyau va devenir trop faible) Apres avoir fait les premieres 5 fentes, tourne le tuyau un demi-tour (180 degrés), laisse une espace de 2cm, et continuer a faire encore 5 fentes (toujours chaque 2 cm). Alors, tourne encores 180 degrés, et fait le meme chose, jusq'ue qu'on a un longeur de 50cm de tuyau avec les fentes a un cote ou l'autre.

Après avoir coupe tout les fentes, etre sur de bien brosser les fentes, pour enlever les petits morceaux coupe de PVC qui peut deranger la fabrique pendant l'installation.

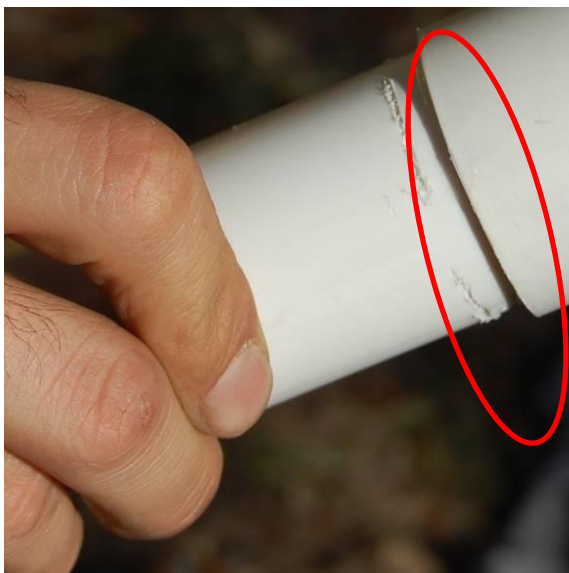
3. Ensuite, coupe une petite épaisseur (“coupure”) sur le tuyau à 10cm en bas des fentes, et aussi 10cm en haut des fentes. ATTENTION de ne pas couper trop sur l’épaisseur. Ces marques seront utilisées pour bien attacher le fil de pêche qui va protéger la fabrication bien sur le mur extérieur du PVC.

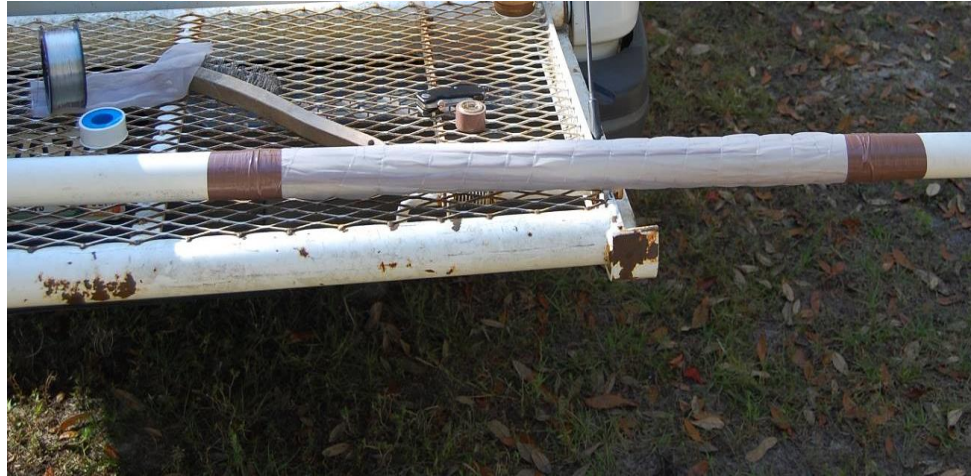
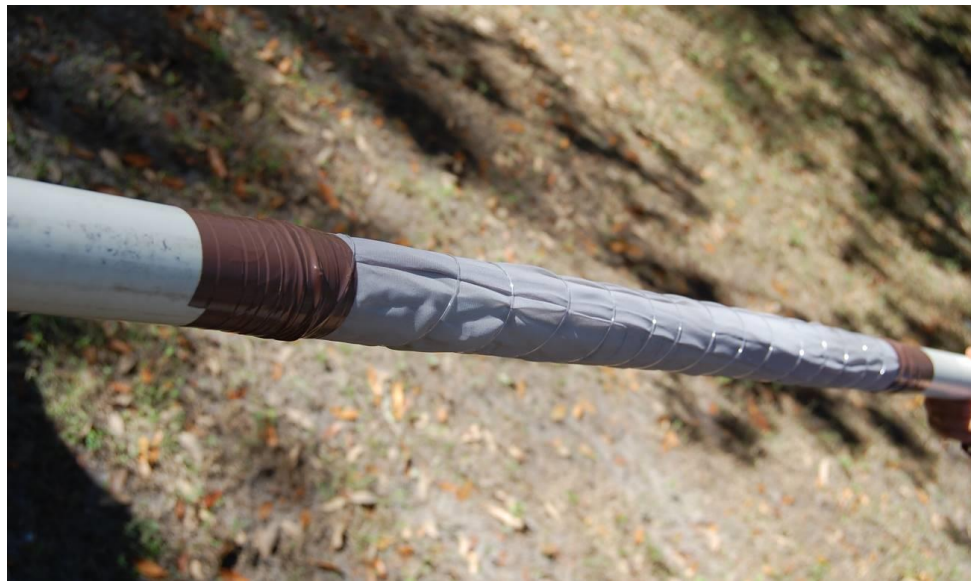
5. Des que le colle a secher, bien attacher le fil de peche sur le petit epaisseur coupe, et ensuite tourner ca autour le diametre de tuyau, en montant le tuyau comme dans les photos ci-dessous , jusqu'au niveau de l'autre coupure en haut des fentes, et bien attache la.

6. Attache du scotch electrique sur les deux epaisseur ou le fil de peche est attache (NE PAS mettre du scotch sur des fentes coupee).
