THE DEVELOPMENT OF A LOW-COST, LEAD FREE WELLPOINT DRILLING
SYSTEM FOR USE IN HOUSEHOLD WELL SYSTEMS IN COASTAL AREAS OF
MADAGASCAR

A Thesis Submitted to the Graduate Faculty
of Mercer University School of Engineering
in Partial Fulfillment of the
Requirements for the Degree

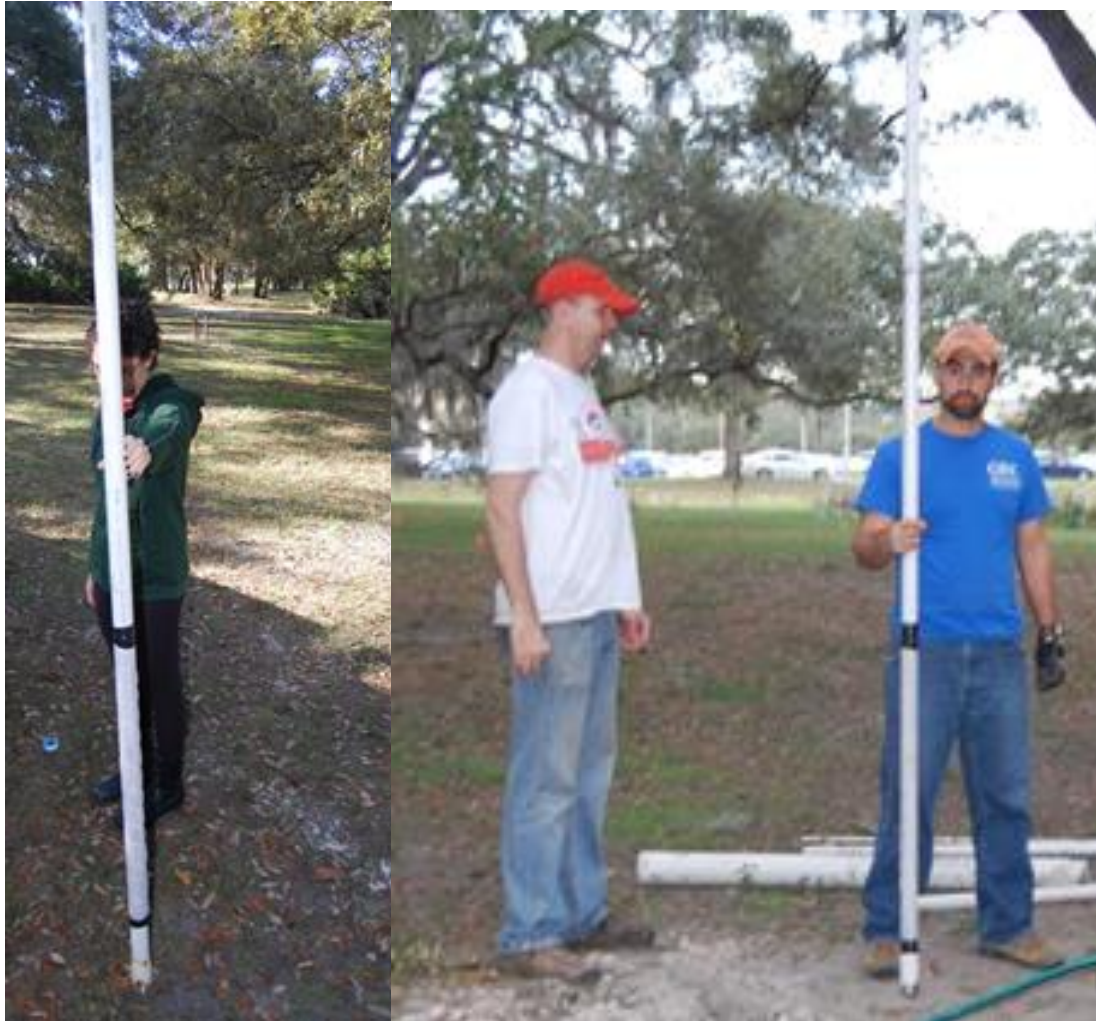
Photo 1 et 2: Tuyaux PVC, pret avec son filtre bien attache, et son point en bas

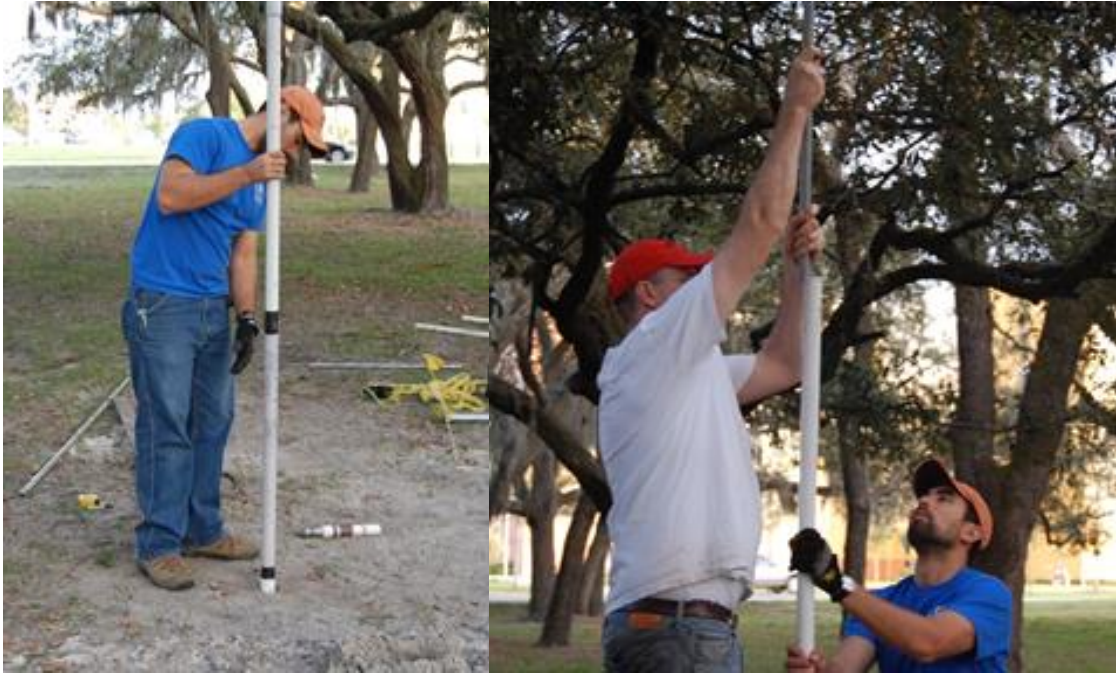
Photo 3 (gauche): en train de mettre le point de tuyau dans le trou (qui est déjà creusé jusque au niveau de la nappe). **Photo 4 (droite):** après le tuyau est installé jusque à la nappe – on met le petit tuyau galva (15/22mm) dans le tuyaux PVC.

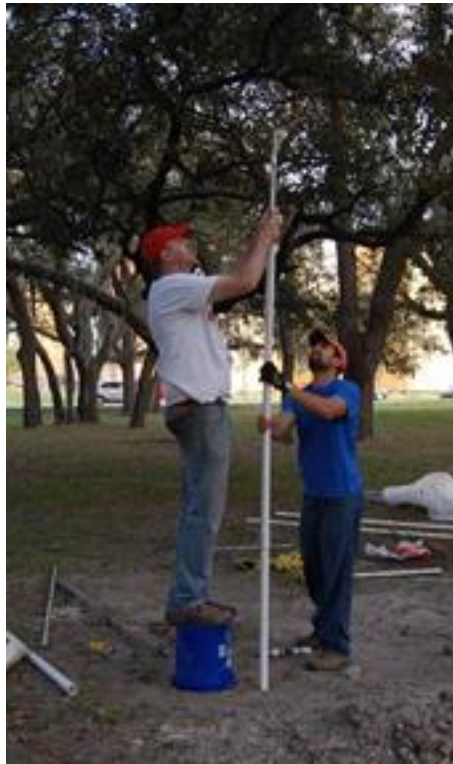
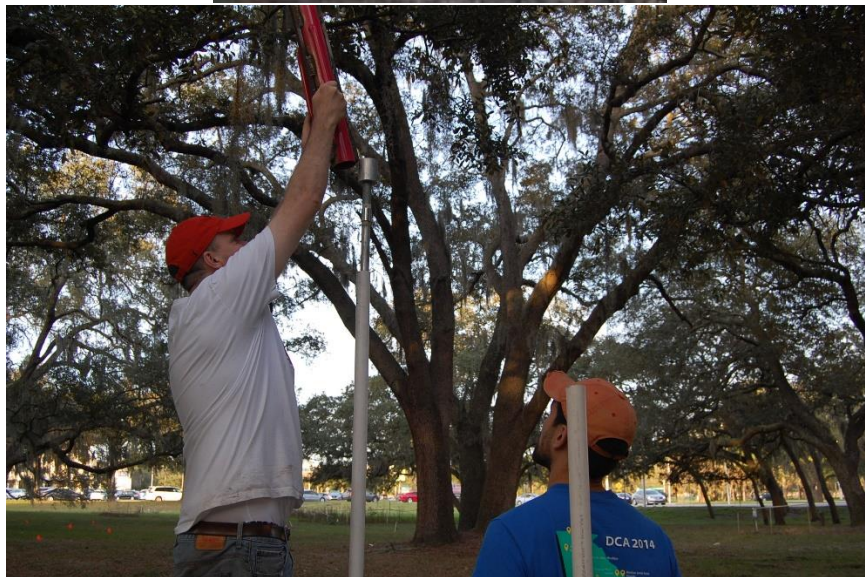
Photo 5 (gauche): actuellement, le petit tuyau galva est déjà dans le tuyau PVC

Photo 6 (droite): Nous avons utilisé un marteau différent (le rouge) pour notre installation, mais Toussaint peut faire comme il fait d'habitude. . .

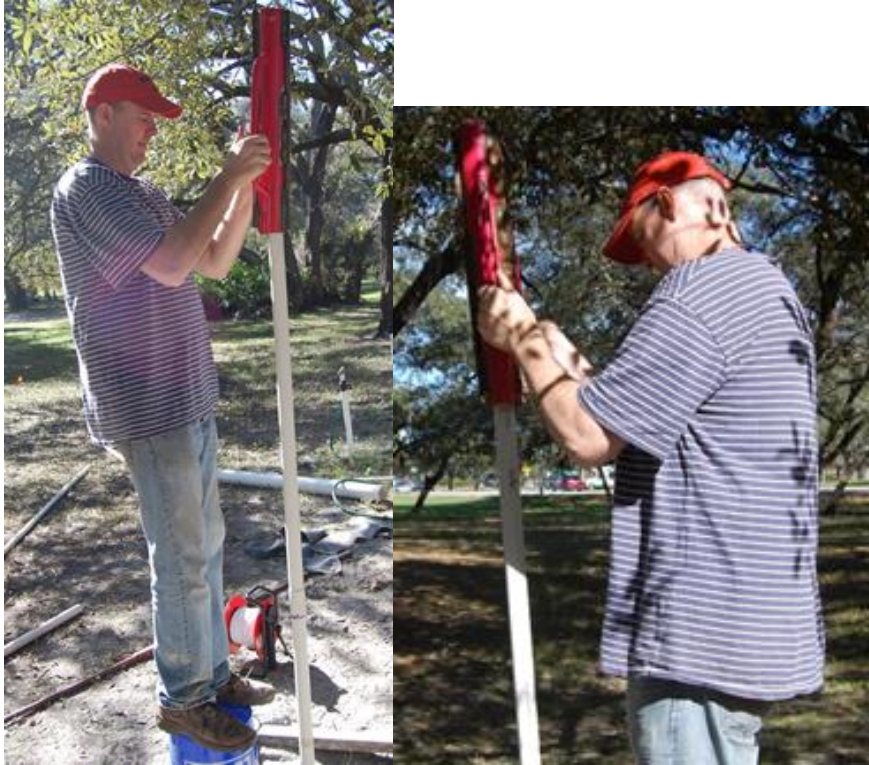
Photos 7 et 8: Tappe le marteau sur le tuyaux galva 15/22mm, qui est installé jusq'ue au niveau de point galva, a l'interieur de tuyaux PVC

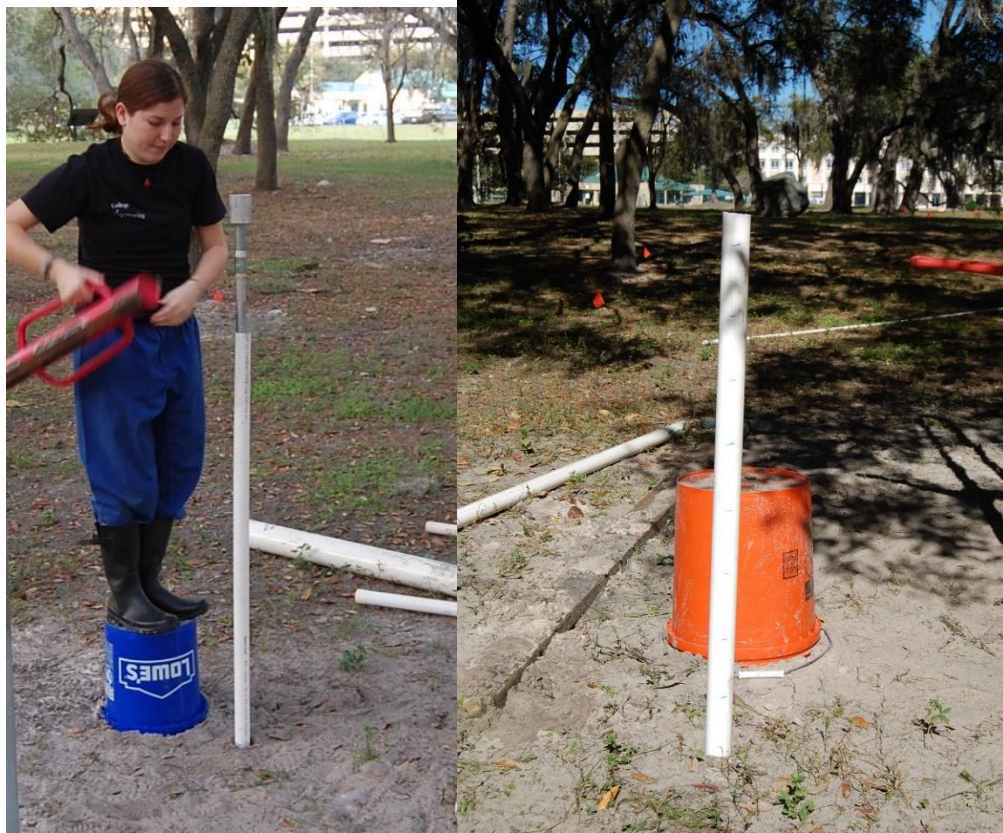
Photo 9 (gauche): Presqu' a la fin de l'installation du forage!

Photo 10 (droite): Apres avoir installée le forage autours de 1 metre et demi (ou mieux 2 metres) dans le sable, on enleve le tuyaux galva 15/22mm! (DERNIER ETAPE, POUR LE MOMENT)
